Urban Flooding: Improvement of Pluvial Drainage System against Saturations on Rondeau Avenue in Paraná

Emanuel Spahn¹ – Nahir Gonzalez²

*Civil Engineering Department, Facultad Regional Paraná, Universidad Tecnológica Nacional
1033 Almaguer Av, Paraná Entre Ríos, Argentina*

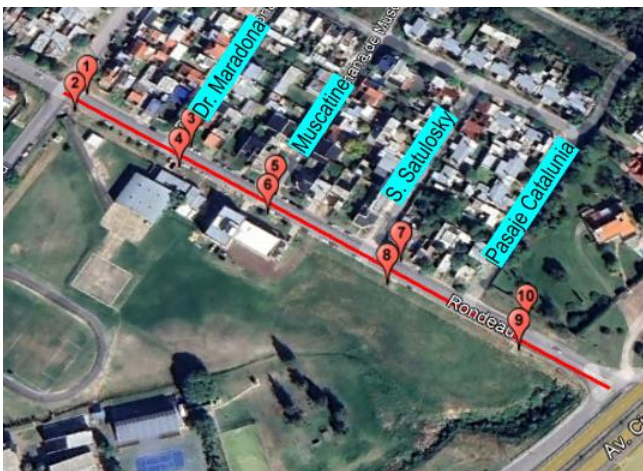
Fig.6. Location of sumps.

This analyzed section of Rondeau Avenue measures approximately 340 meters. It serves as a transitional pathway between the elevated area of Fraternidad Street and the lower zone of Uranga Avenue. Covering these two zones there is a seven-meter elevation difference, so the lengthwise slope of the street is important. Moreover, the rainwater drainage system consists of ten sumps, as indicated in Fig.6.

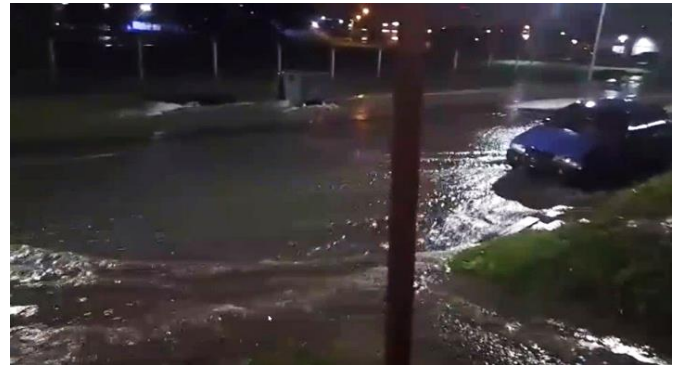
Fig.7. View of an inundation on Rondeau Avenue.

As can be observed in Fig.7, on a heavy rainy day, the street is overflowed from side to side and also advances onto the edges of the sidewalk. To the right of Fig.7, you see a parked car near the curb. Another car passed by a few minutes earlier, causing the water on the left side of the photograph to form waves.

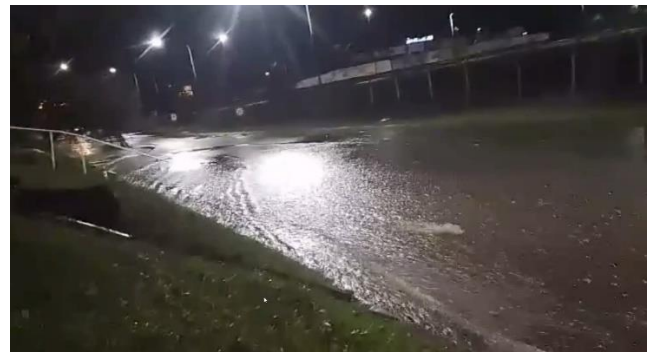
Fig.8. Flooding at the end of Rondeau Avenue.

In Fig.8, you can see the water flowing from east to west, following the direction of the North Access Route. On the right side of the image, you see that the water level from the sidewalk reaching from side to side. Drains or storm drains cannot cope with the volume of this flow.

In the background of the photograph, it appears that the water is attempting to flow on the route. The street is 12 meters wide and the sidewalk extends up to the boundary of the Police School, covering 4 meters wide. Cars must circulate very carefully so as to avoid any risk caused by the sediments brought by the water's current.

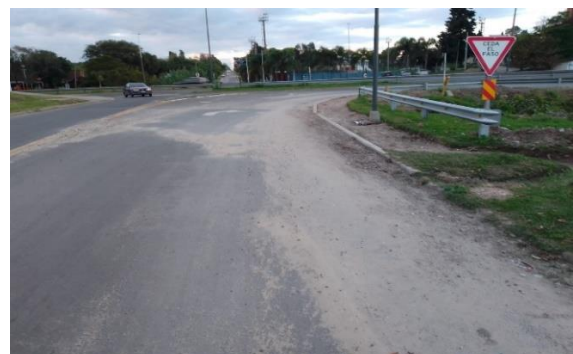
Fig.9. Sediments in the curve to Uranga Avenue.

In Fig.9, you can see that there is a lot of dirt accumulated on the asphalt of the street after rainfall. Also, there is much more sediment on the edges of the curb, and there is a layer of soil between the middle and the edge of the street.

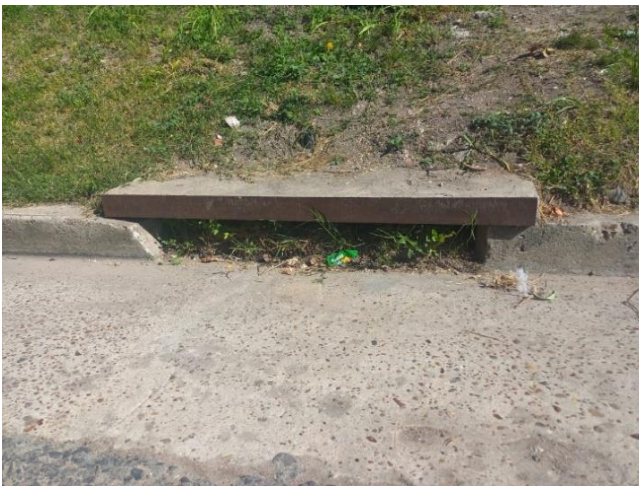
Several causes of this problem can be named. One reason for this situation is the poor maintenance of the stormwater drainage system. When precipitation occurs, water flowing over the road carries sediment and dirt. This cumulative effect has become significant over time. The Municipality of Paraná, which is the entity in charge of cleaning these storm drains, has not carried out the minimum maintenance necessary for their correct operation over the years. This has caused the clogging of three out of ten storm drains, specifically those closest to Uranga Avenue.

Fig. 10. View of a clogged storm drain.

In the second place, the maintenance service must be considerably improved. Nothing will work out properly if the periodic cleaning of storm drains is not thoroughly done by the competent entity, the city's municipality. This service must focus mostly on sinks number 5, 7 and 10 because of their small dimensions. In the case of sink number 10, a complete-unclogging must be done.

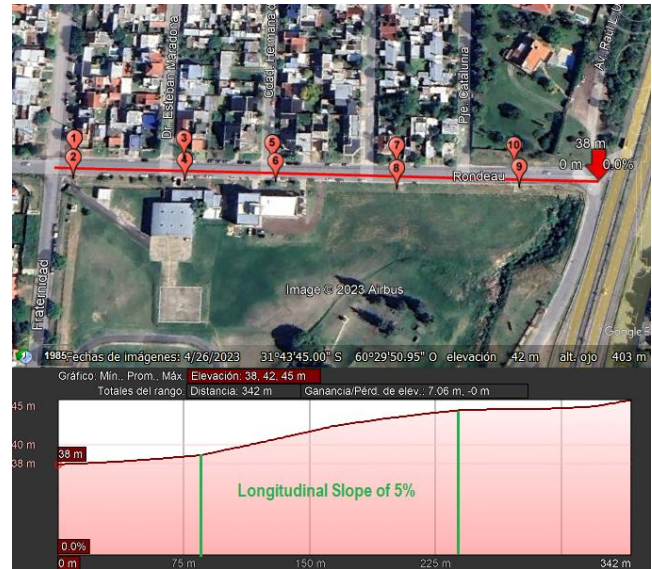
Fig.11. Elevation profile of the street.

Another cause is related to the incorrect design of the stormwater drainage system. Storm drains must be designed under certain guidelines related to hydrology and engineering. The type of storm drain used in this area is known as a curb opening inlet [1], and its operation is optimal when the longitudinal slope of the road does not exceed 3%. In the case of the area under study, there is a central area an inclination of approximately 5%, so two out of nine storm drains found in this area probably function poorly.

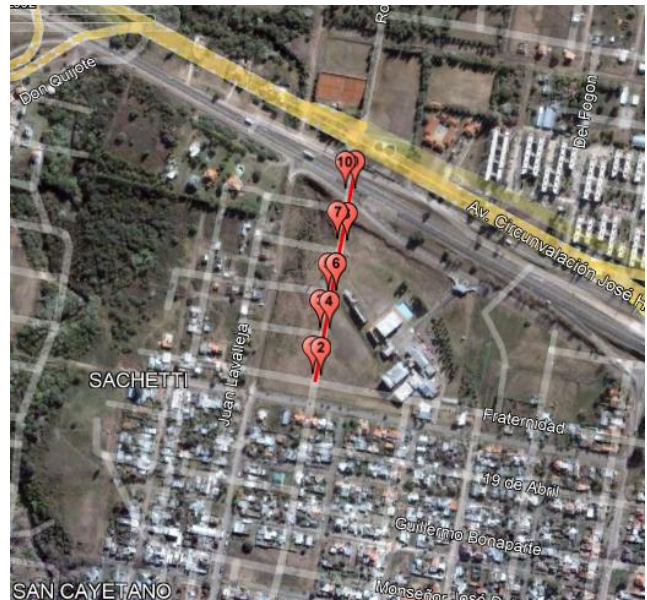
Fig.12. View of the sector in 2002.

The obsolescence of the drainage system due to urban development over time is another cause that can be mentioned. Based on a hydrological study of a region, it can be concluded that storm drains are designed to handle a specific water flow. As the built-up area of a region expands over time, there is less surface area available to absorb precipitation and, therefore, there is a decreased water runoff. The entire sector under study has suffered a large increase in its built-up area in recent years, which can be seen by comparing Fig.12 (year 2002) with Fig.13 (year 2023). This expansion has caused stormwater drainage system to become practically inoperative.

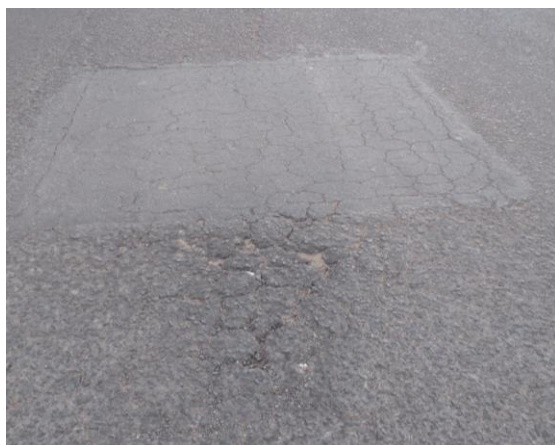
Finally, we can highlight that floods gradually cause cracks in the pavement. Moreover, the growth of existing cracks due to traffic, make the useful lifespan of the asphalt layer progressively diminish.

Fig.14. Roadway deterioration and repairs.
