ROAD IMPROVEMENT: RECONDITIONING OF GUTIERREZ STREET IN PARANÁ

Universidad Tecnológica Nacional
Facultad Regional Paraná
Civil Engineering Department
Inglés 1
2023

Nahuel Mussin, Máximo Borghello and Simón Vitale.

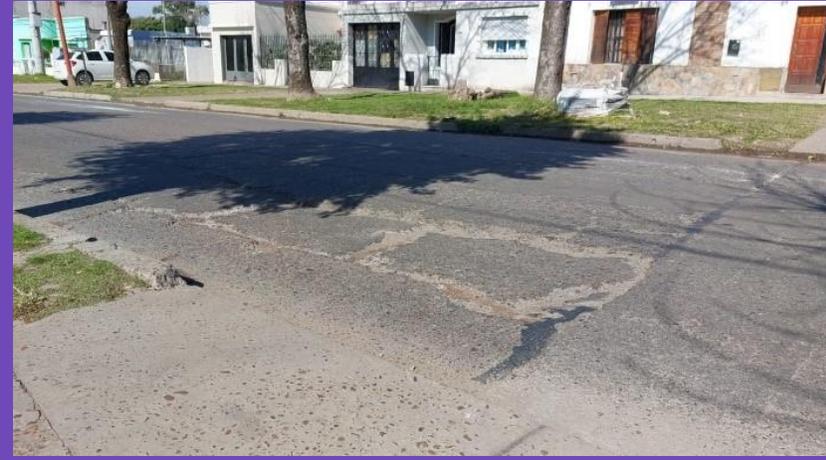
Poor road conditions due to large potholes in the street

The current condition of Gutierrez Street

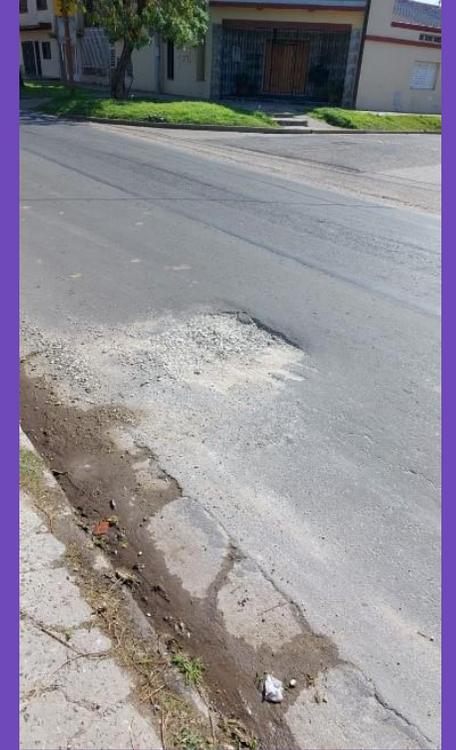
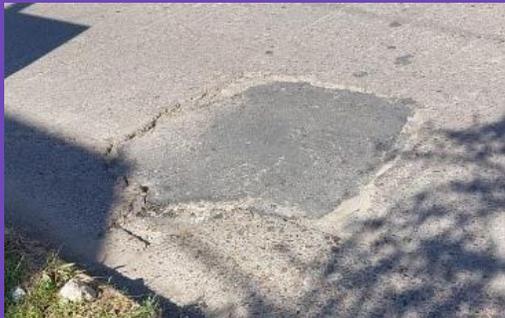
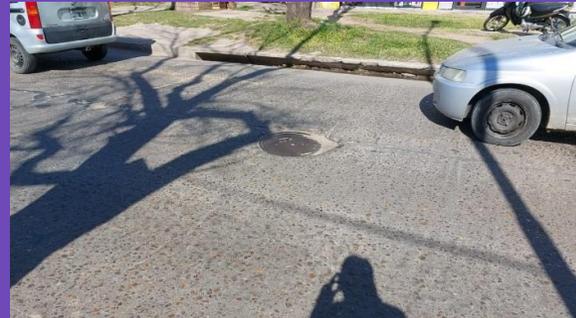
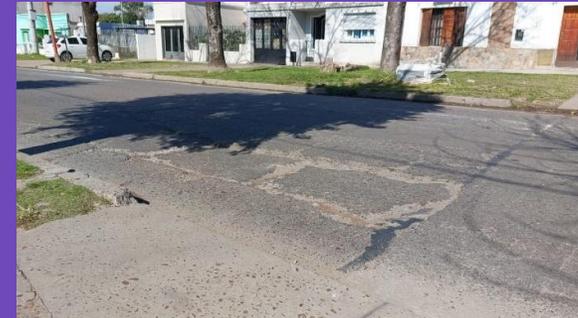
- At the intersection of Coronel Martinez Street
- At the corner of Virasoro Street
- In the storm drain in Gutierrez Street
- At a central point on Gutierrez Street, between Virasoro and Piran Streets

Reconstruction of the Road Using Another Method

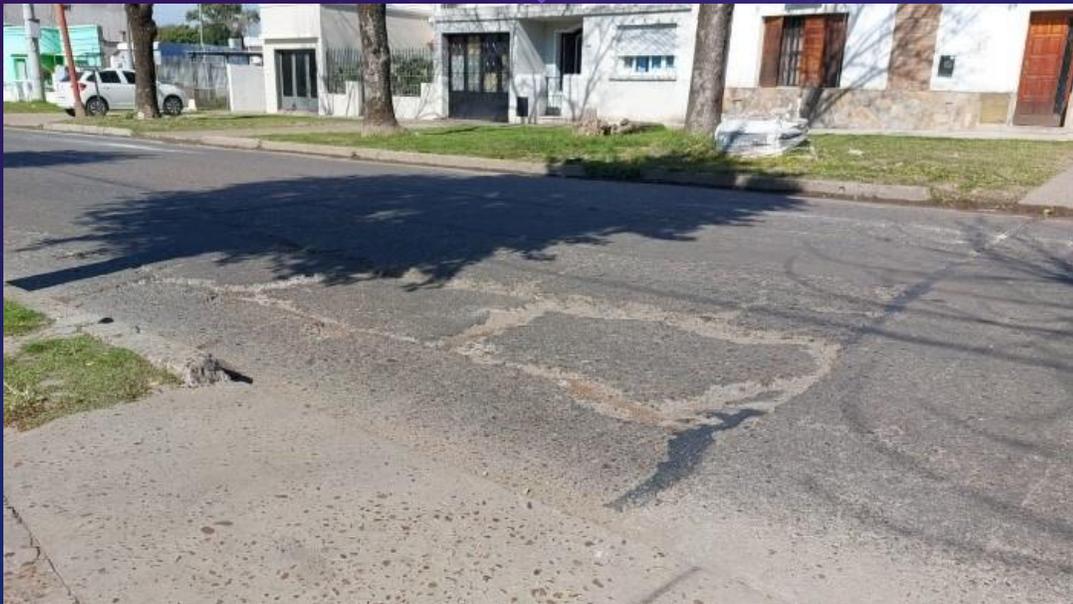
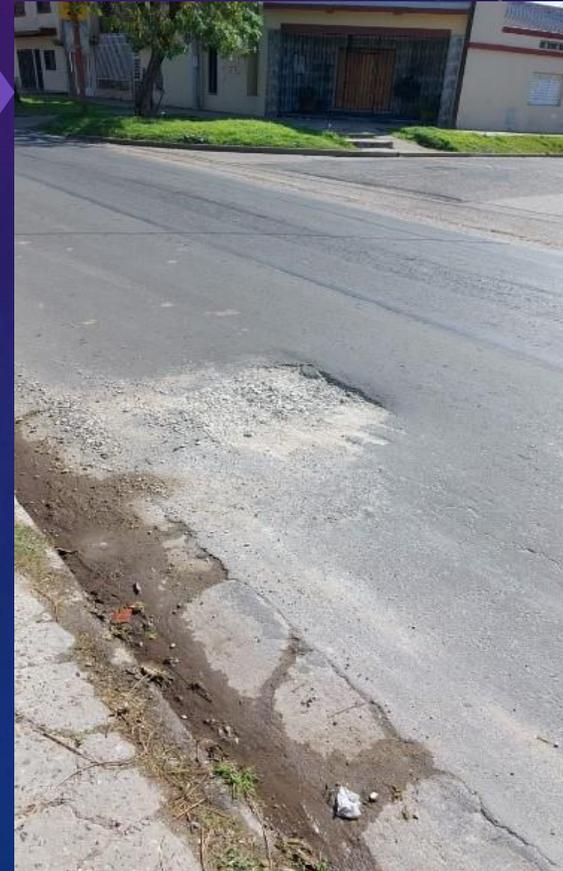
- Central Gutierrez Street, between Virasoro and Piran Streets
- Pothole at the intersection of Coronel Martinez Street

- The lack of maintenance
- The type of soil in Paraná
- The heavy traffic
- The poor quality of the street structure

- Old road removal
- Reconstruction of the road using Method AASHTO 93
