Infrastructure in Poor Condition: Reconstruction and Maintenance of Potholes at the Corner of Francia Street and Rio Negro Street in Paraná City

Tanya Muller¹ – Sofia Sattler² – Ana Paula Tomassi³

*Civil Engineering Department, Facultad Regional Paraná, Universidad Tecnológica Nacional
1033 Almaguero Av, Paraná Entre Ríos, Argentina*

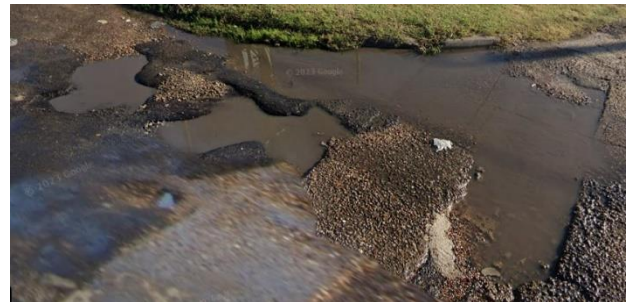
Figure 5 shows the problem. As you can see, the pothole is located in a corner and is filled with water. This situation is very worrying and requires a solution to guarantee the time, safety and well-being of those who want to travel along this street.

Fig. 5. Pothole filled with water on Francia Street.

The issue addressed here is a pothole in Universitario neighborhood. As mentioned before, this pothole is at the intersection of Francia Street and Río Negro Street. It has a dimension of 2.16 x 0.80 meters, causing pronounced flooding in that corner. It has undergone many repairs but, as we mentioned before, the lack of maintenance is a critical factor in this problem and proper maintenance has never been carried out correctly.

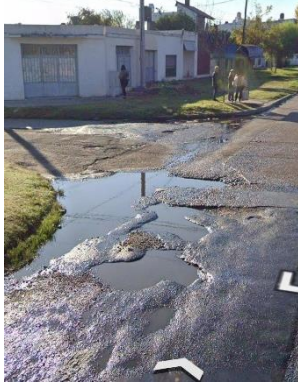
Figure 6 shows the big size of this road surface depression, which is filled with standing water. In the background of the photo, it can be seen that there is a group of neighbours waiting for the bus, which is experiencing a delay in completing its route along Francia Street due to the lack of pothole repair.

Fig. 6. Illustration of the pothole on Francia Street.

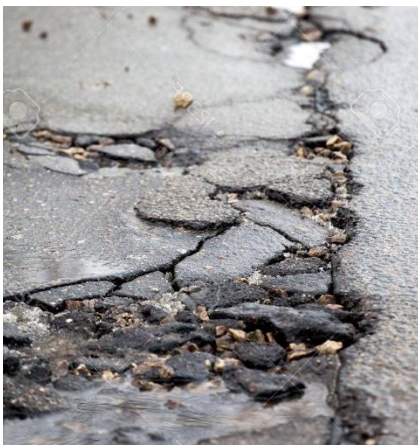
The extreme weather conditions that are experienced in Paraná produce very noticeable changes in the environment. During cold winters, water can infiltrate cracks in the pavement. When this water freezes and then thaws, it expands and weakens the pavement (Fig. 7).

Fig. 7. Impact of extremely low temperature on pavement quality.

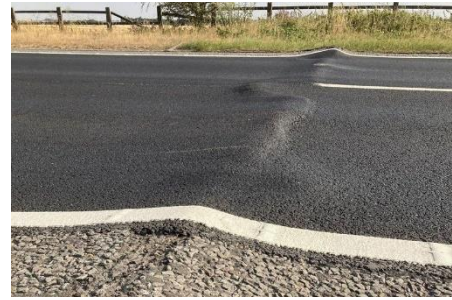
The very high temperature also affects road works. When creating pavement, the softening point must be taken into account since once that point is exceeded, the asphalt will begin to deform. Both extreme climates can produce deformations in pavement that can lead to the formation of potholes (Fig. 8).

Fig. 8. Impact of extremely high temperature on pavement quality.

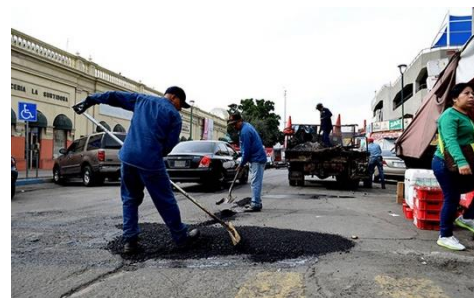
The lack of regular pavement maintenance is a third cause for this problem. The absence of crack filling or surface sealing, can lead to the infiltration of water and other elements into the pavement structure. When water enters the upper layers, the asphalt binder separates from the stone aggregate, generating potholes more easily (Fig. 10).

Fig. 10. Pavement maintenance.

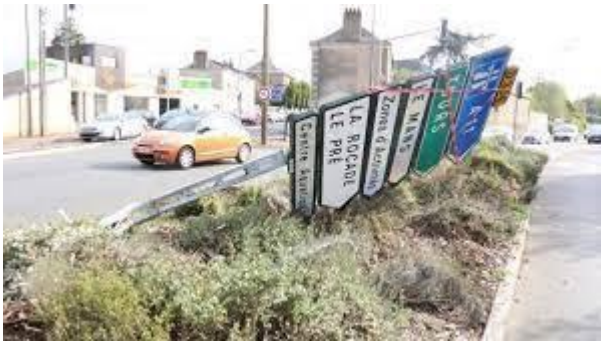
Fig. 11. Poor signage.

In the first place, this pothole presents a road safety risk. It can be a serious threat due to the possibility of causing accidents involving vehicles and pedestrians, especially if drivers try to swerve abruptly to avoid it due to poor traffic signage there. (Fig. 11).

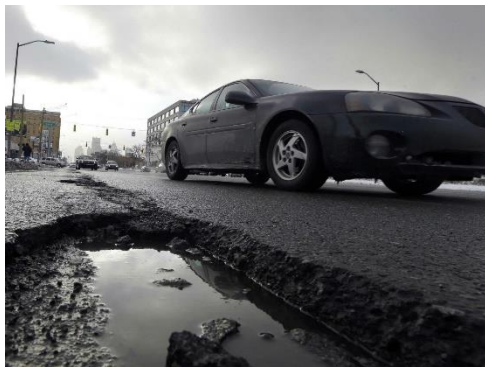
Fig. 13. Vehicle's Safety Hazard because of this pothole.

France Street is very travelled by trucks through to Cotapa factory, therefore the size of the pothole intensifies. This is a real concern for drivers, as it can cause a series of significant damages to vehicles. These range from simple annoyances like vibrations and noises to more serious problems like flat tires and misaligned wheels. Furthermore, it not only affects the visible components of the vehicle, but can also trigger more complex mechanical problems in the suspension and steering system. These problems cause a decrease in the stability of the car, endangering the safety of passengers. (Fig. 13).

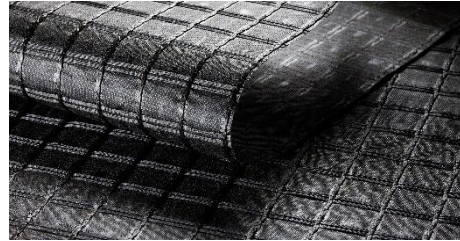
The proposed solution will consist of the use of polymeric materials for the resurfacing of the street. The use of polymeric materials consists of the addition of polymers to asphalt in order to improve its mechanical properties. Although there are many available materials, we opted for the geogrids (Fig.14).

Fig. 14. Geogrid for resurfacing.[1]

In relation to geogrids, they can be described as structures of flat, orthogonal and open meshes. They are made up of synthetic woven filaments (polyester, polypropylene, polyamide or polyvinyl alcohol) with a polymeric coating, suitable for resisting high tensile stresses [2].

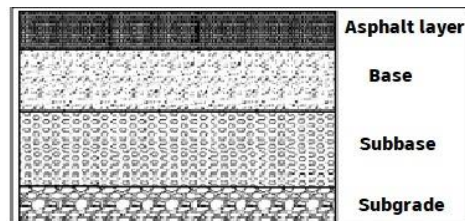
Geogrids can only be applied to flexible pavements; which are constructed using one or several asphalt layers and/or selected or treated materials with depth. The structural package of such pavements comprises four layers (Fig. 15):

- Asphalt layer: This forms the road surface and consists of a mixture of stone aggregates and asphalt, with the latter being the foundation for this type of pavement.
- Base: Its main function is to transmit and distribute the loads from the pavement to the lower layers, which include the subbase and subgrade.
- Subbase: It is a granular layer that acts as a filter so that particles of fine material that could damage the subgrade are not introduced.
- Subgrade: It is the starting level of the structural package, which is, in turn, the earthwork level of completion prior to the construction of the structural package.

Fig. 15. Structural package layers.

Geogrids are applied above the base. Their application is simple and effective, no specialized personnel are needed.

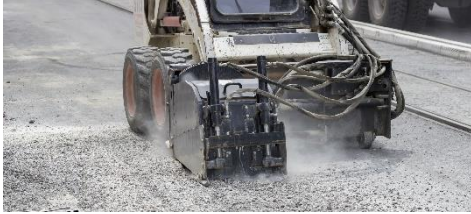
- Step 1: First the pavement milling is carried out and then the existing cracks are sealed (Fig.16).

Fig. 16. Pavement milling.

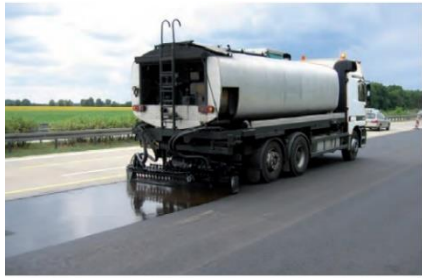
- Step 2: The surface is treated with a bitumen-based glue, as seen in Figure 17, before geogrid installation.

Fig. 17. Garter irrigation.

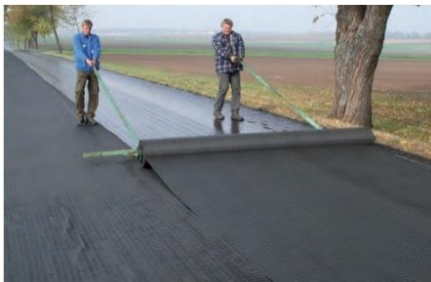
- Step 3: Geogrids are extended and secured using steel nails and washers, which should not be separated by more than 1 m apart to guarantee their fixation.
- Step 4: Joints between reinforcing steel bars are secured allowing a 10cm longitudinal extension and a 15cm transverse extension.

Fig. 18. Geogrid Collation.

- Step 5: The surface is cleaned prior to priming, and a layer of glue is applied on the geogrids (Fig. 18).
- Step 6: A layer of asphalt is placed over the geogrids to protect the mesh from possible damage that may be caused by the covers of the machinery and equipment (Fig.19).

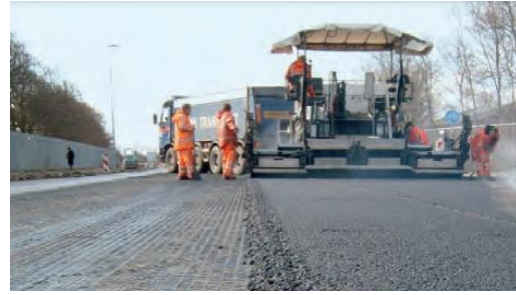
Fig. 19. Asphalt venting.

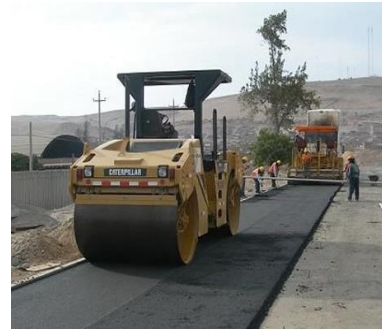
- Step 7: The asphalt is installed as shown in Figure 20.

Fig. 20. Final Asphalt Installation.

- Step 8: The thickness of the asphalt is verified since the geogrids must be protected by a layer of no less than 8cm.
- Step 9: The final compaction of the asphalt is also carried out to leave it ready for safe use.
