# Achieving a suitable hygro-mechanical compatibility between the substrate and the repairing mortars in historic masonry constructions.

Domizio M.<sup>1,2\*</sup>, Maldonado N.<sup>1</sup> and Fernández Luco L.<sup>3</sup>

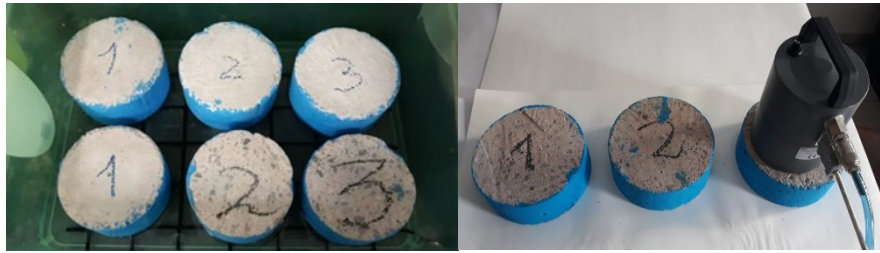
a) b)  
**Fig. 2** Provision of specimens for suction test (a) and air permeability test (b).

To characterize the behavior of repair mortar and substrate, the capillary suction test was conducted that guides the level of impermeability of the mortar (IRAM, 2004). Fig. 2.a shows the laboratory test layout and the result of it in Fig. 3.

The air permeability test studied by Ebensperger and Torrent (2009) and Romer (2005), which allows guidance on the quality of the mortar used as indicated by Dobel et al (2013), has been used to verify the behavior of the mortar-mortar interface (Fig. 2b and 4).

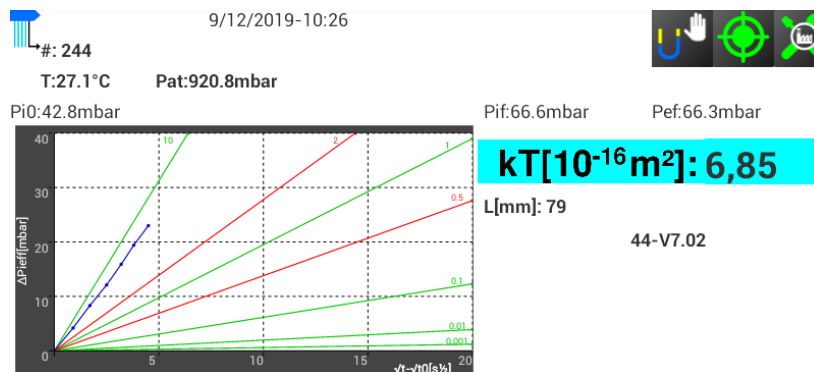
Fig. 4 One measuring test on the screen of equipment (b).

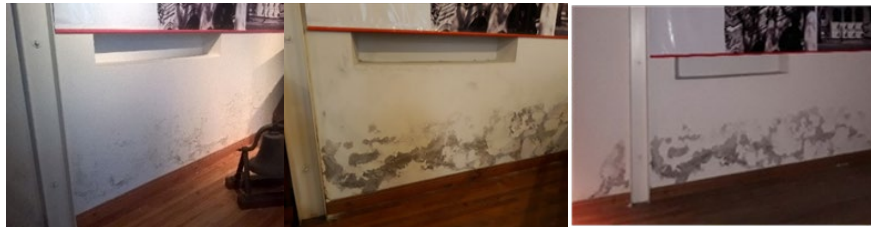
a) b) c)

Fig. 5 South Wall #3 State in a) 2017 b) 2018 c) 2019

The use of cementitious plasters, generated new problems in the rehabilitated building, because there are chemical and physical incompatibilities with the heritage masonry. Over the years, large concentrations of sulfate salts were deposited inside the walls. The combination of these salts present in the masonry, the cement hydration compounds of the new plasters, high humidity conditions and low temperatures during their placement; made possible the formation of thaumasite and ettringite, two salts that cause the appearance of efflorescence; and then, expansion, cracking and disintegration in mortars (Maldonado et al, 2017) (Fig. 5).

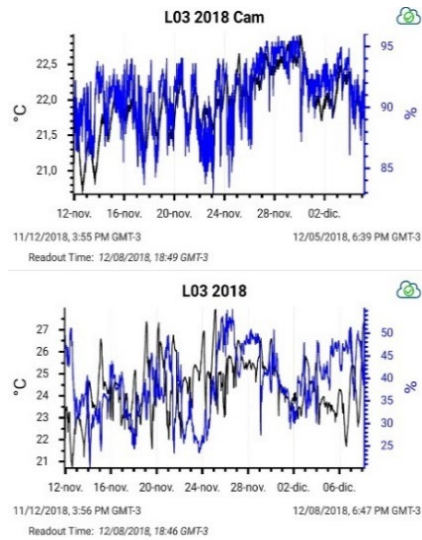
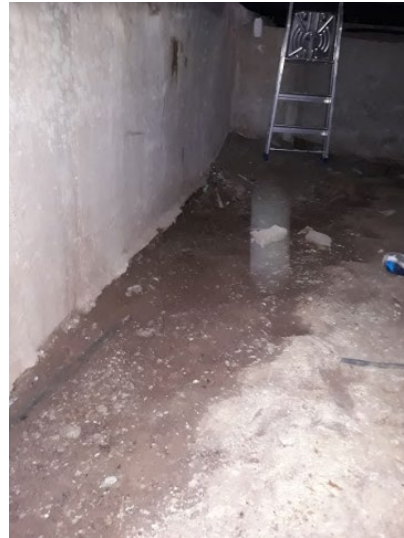
**Fig. 7** Humidity and temperature data in the ventilation chamber of room 3 and in the habitable zone of the same room (a). Photograph of the interior of the ventilation chamber of room 3 (b).

The monitoring of temperatures and humidity was carried out with HOBO brand data-loggers, inside the premises, inside the ventilation chambers, and also outside. It was verified that the relative humidity in the ventilation chambers of the premises was around 80-90% (Fig. 7a). The reason for the high humidity in the ventilation chamber of a room, after a visual inspection of it, was that the floor was very wet, close to the

foundation beam of the south wall, which borders an old construction and in poor building conditions. The chemical analysis of the soil detected the presence of *escherichia coli* that corresponds to contamination due to loss of sewage effluents.

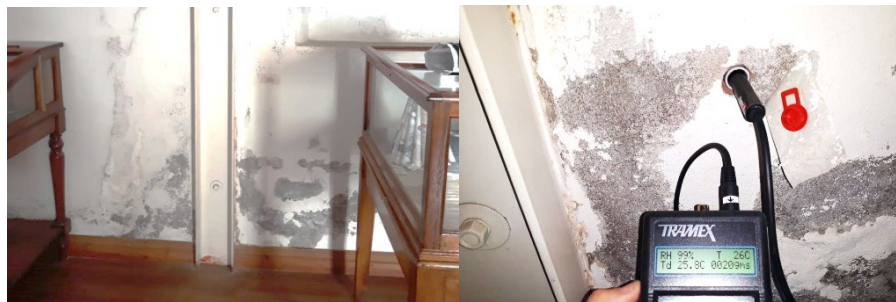
**Fig. 8** Provision of probes to measure internal wall moisture and measurement (a). Internal humidity measuring point in room 3 (b)

The value of the internal humidity of the party walls with Tramex humidimeter has also been verified, exceeding the average values of 99% relative humidity, which indicates the saturation of the masonry and the consequent problem that affects the mortars of coatings, since the presence of soluble salts is located above the level +1.50 m (Fig. 8).

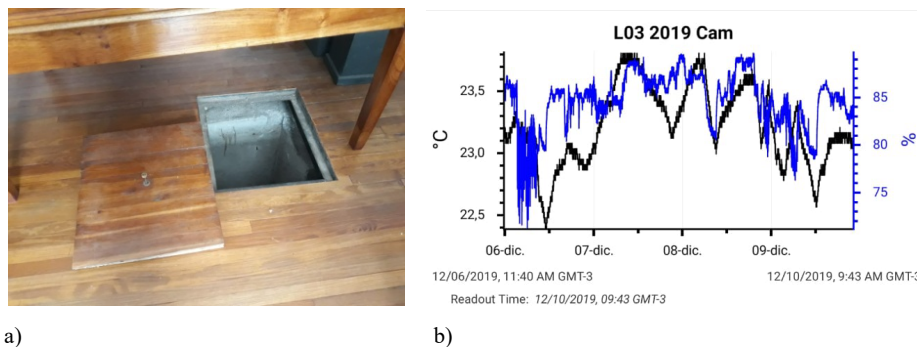
**Fig.9** Basement air chamber cover opening (a). Measure of humidity and temperature data in the ventilation chamber of room 3, after opening of the mouths of the air chambers in summer (b).

The opening of the mouths of the air chambers in summer has shown an effective reduction of the moisture content, a 5% decrease in five days, but they are not compatible with the current uses of the building (museum) such as the use of natural cross ventilation (Fig. 9).
