ARCHAEO-METALLURGICAL STUDY OF ARGENTINIAN RAILWAY PARTS

Analysis of two historical railway parts reveals the techniques and treatments used on these metals that helped them endure centuries of use.

Patricia Silvana Carrizo, National Technological University Mendoza Regional Faculty, Argentina*

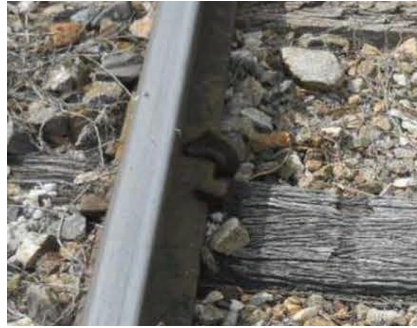
Fig. 2 — Example of a hook-type fixing nail.

“Fixing” is defined broadly as the main small material used to attach or fix rails to the sleepers (Fig. 2). The main functions of these rail fasteners were to:

- ensure the consistency or invariability of the rail
- facilitate the transfer of the static and dynamic loads to the infrastructure of the track (platform) exerted by the rolling stock on the structure of the track (railway package)
- possess mechanical strength and constant elasticity throughout the long life of the fixation
- contribute to good electrical insulation between both rails

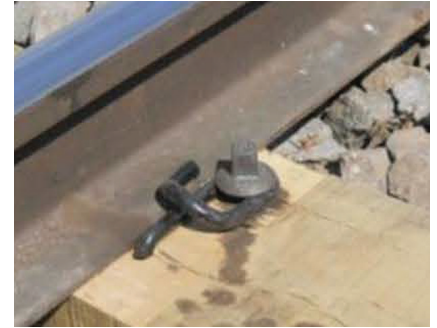
Fig. 3 — Example of a gauge-lock (Pandrol clip).

The number of required fixing pieces should be small to facilitate their manufacture, placement, and conservation, and minimize cost. The fixings for wooden sleepers can be divided into rigid and elastic defined by the way of carrying out the support and by the type of support: direct (without saddles) and indirect (with saddles). Rigid fixings (without saddles) include the nail hook and the screw. Elastic fixings (without saddles) include the single and double elastic nail, the shun, and gauge-lock (Pandrol clip) as shown in Fig. 3.

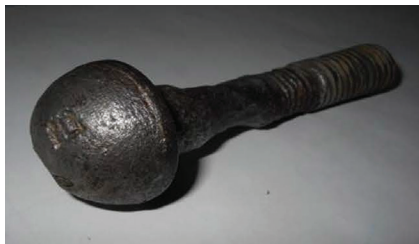
Fig. 4 — Threaded bolt, where the letter B (BAP) is seen.

The pieces received to investigate included a bolt of the threaded type (Fig. 4) and a fixing nail (Fig. 5) used in the section of the BAP railroad that connected Mendoza with San Rafael south of the Mendoza province. Both pieces belong to the San Rafael Railway Museum. The bolt would have been used to distribute the efforts (loads) on the rails and the fixing nail helped prevent variations in the gauge width and separation of the railway tracks.

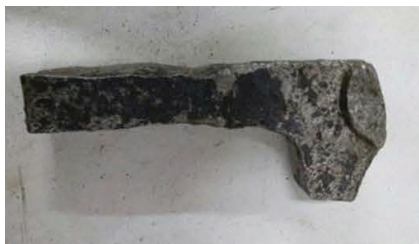
Fig. 5 — A fixing or clamping nail.

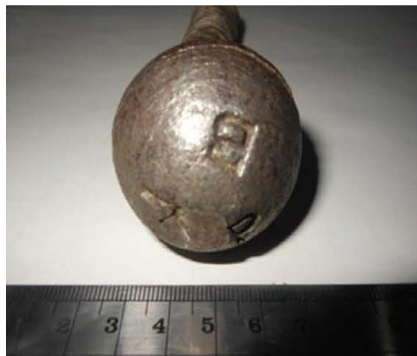
Fig. 6 — Bolt head.

In the metallography of the bolt head (Fig. 6), a ferrite-perlite structure is observed. The micrographs show that there is a decrease in the grain size of the constitutive raw material due to the machining work performed on the piece (Fig. 7). The machining that would have been used to create this kind of head is called “drop of bait,” due to its final shape, and is typical of the first era of railways.

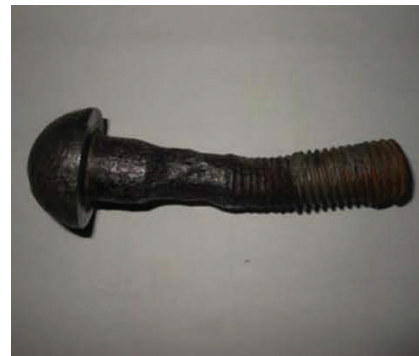
Fig. 8 — Threaded bolt.

In the micrograph of the threaded bolt rod (Fig. 8), a cast iron structure of high strength, low alloy, and low carbon

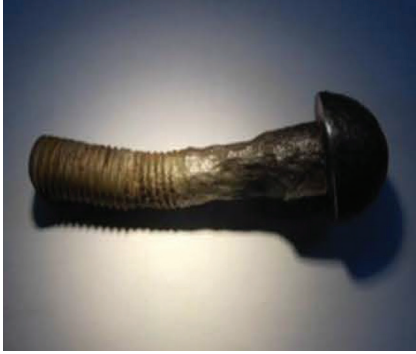
Fig. 10 — The threaded bolt that was studied.

At the time of manufacture, standardized or specified threads were not yet established, so the thread comb does not match the sample under study (Fig. 10). However, the thread it most
