URBAN FLOODING: IMPROVEMENT OF PLUVIAL DRAINAGE SYSTEM AGAINST SATURATIONS ON RONDEAU AVENUE IN PARANÁ

Civil Engineering Department, Inglés I

This work is an EFL engineering student project. The pictures and content in this presentation are only used for educational purposes. If there is any copyright conflict, they will be immediately removed.

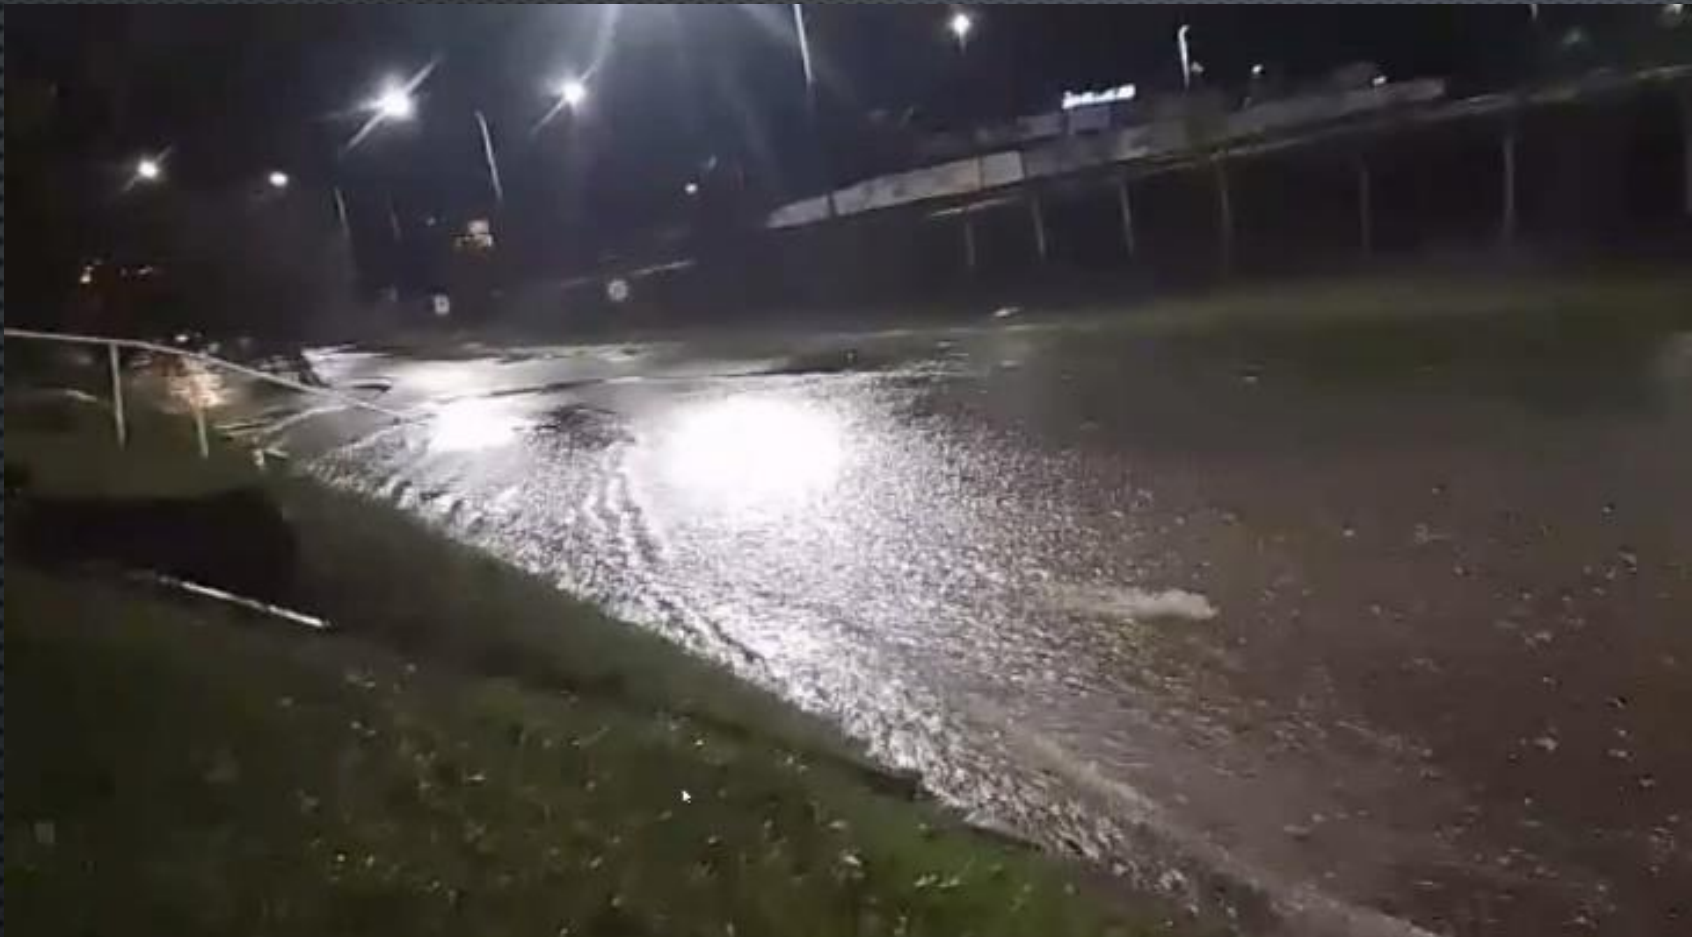
- Urban drainage problems in Paraná during a heavy rain
- Drainage system's poor performance and high runoff flows

Rondeau Avenue, between Fraternidad Street and Raúl L.
Uranga Avenue, on a rainy day

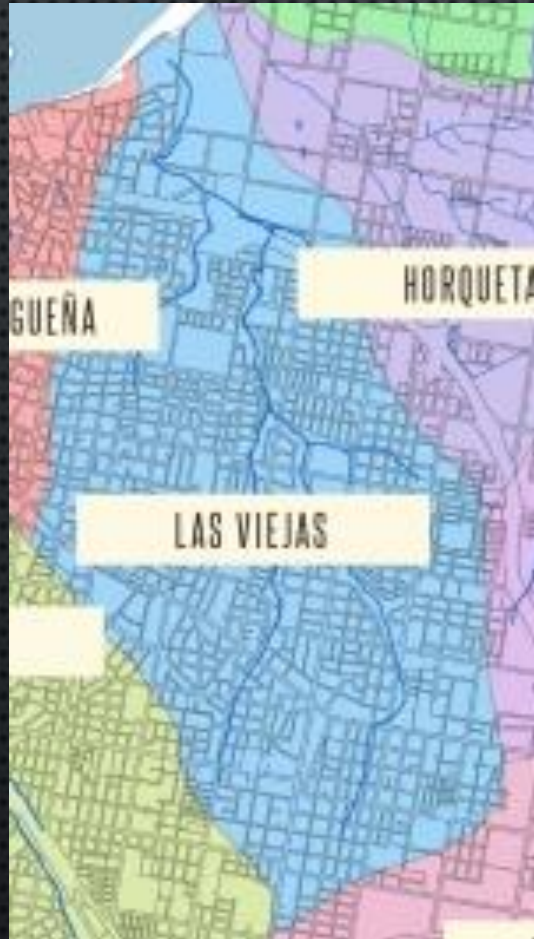
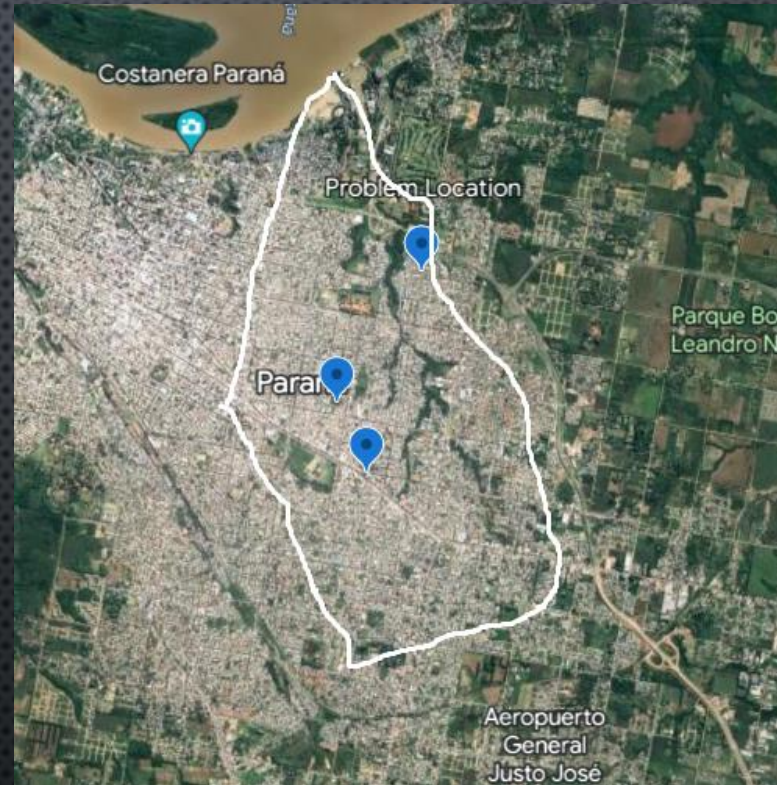
Las Viejas Stream's Basin

- Located in the north of the city
- Surface of 12,3 Km²

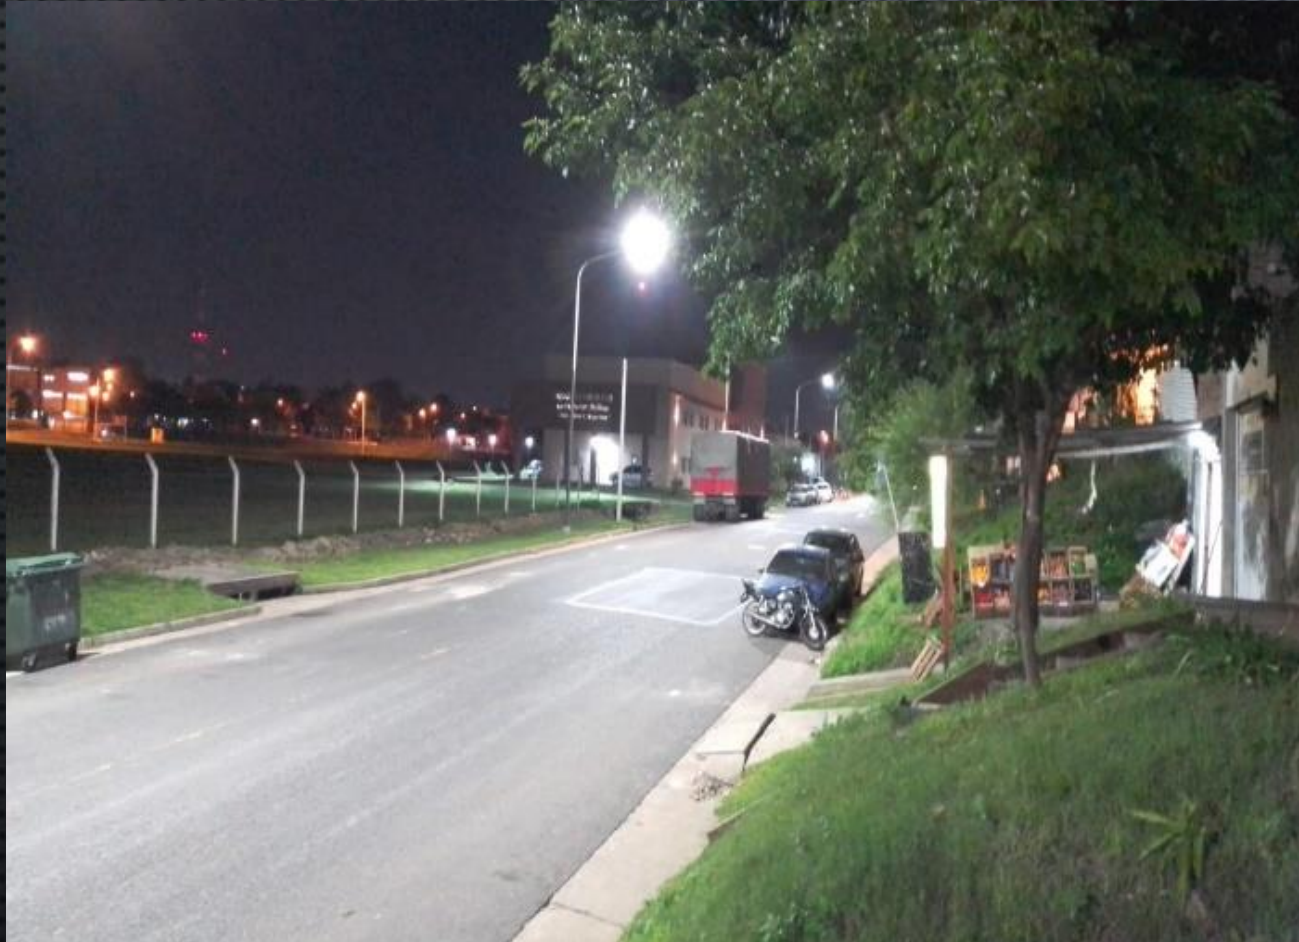
Rondeau Avenue's Analyzed Section

- Length of 340 meters
- Unevenness of 7 meters
- High longitudinal slope

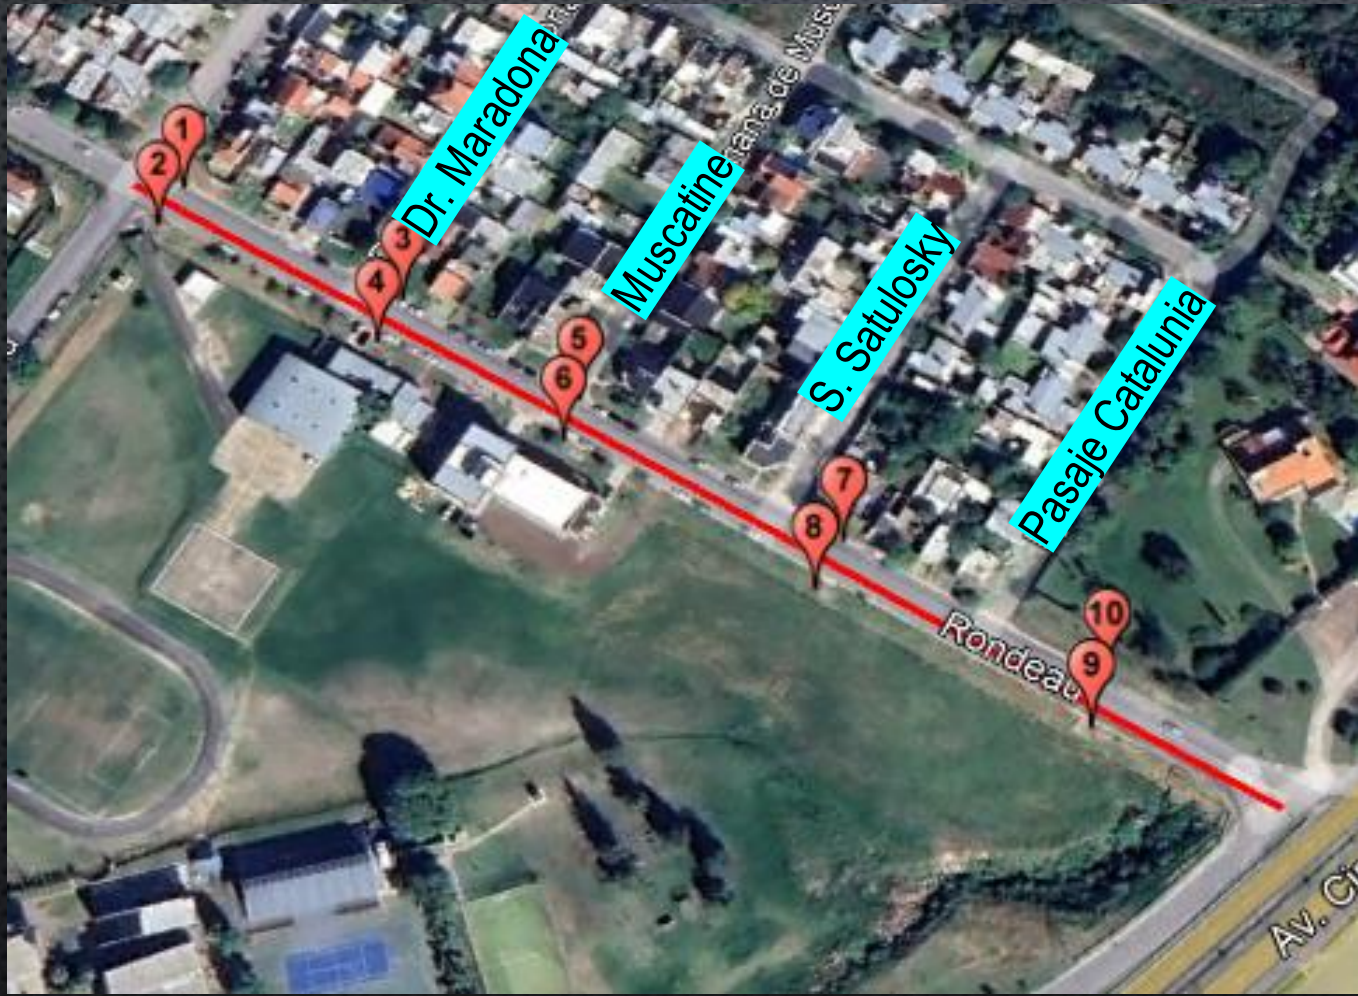
Rondeau Avenue's Analyzed Section

- Drainage system integrated by 10 sumps
- Water runoff from other elevated streets when it rains

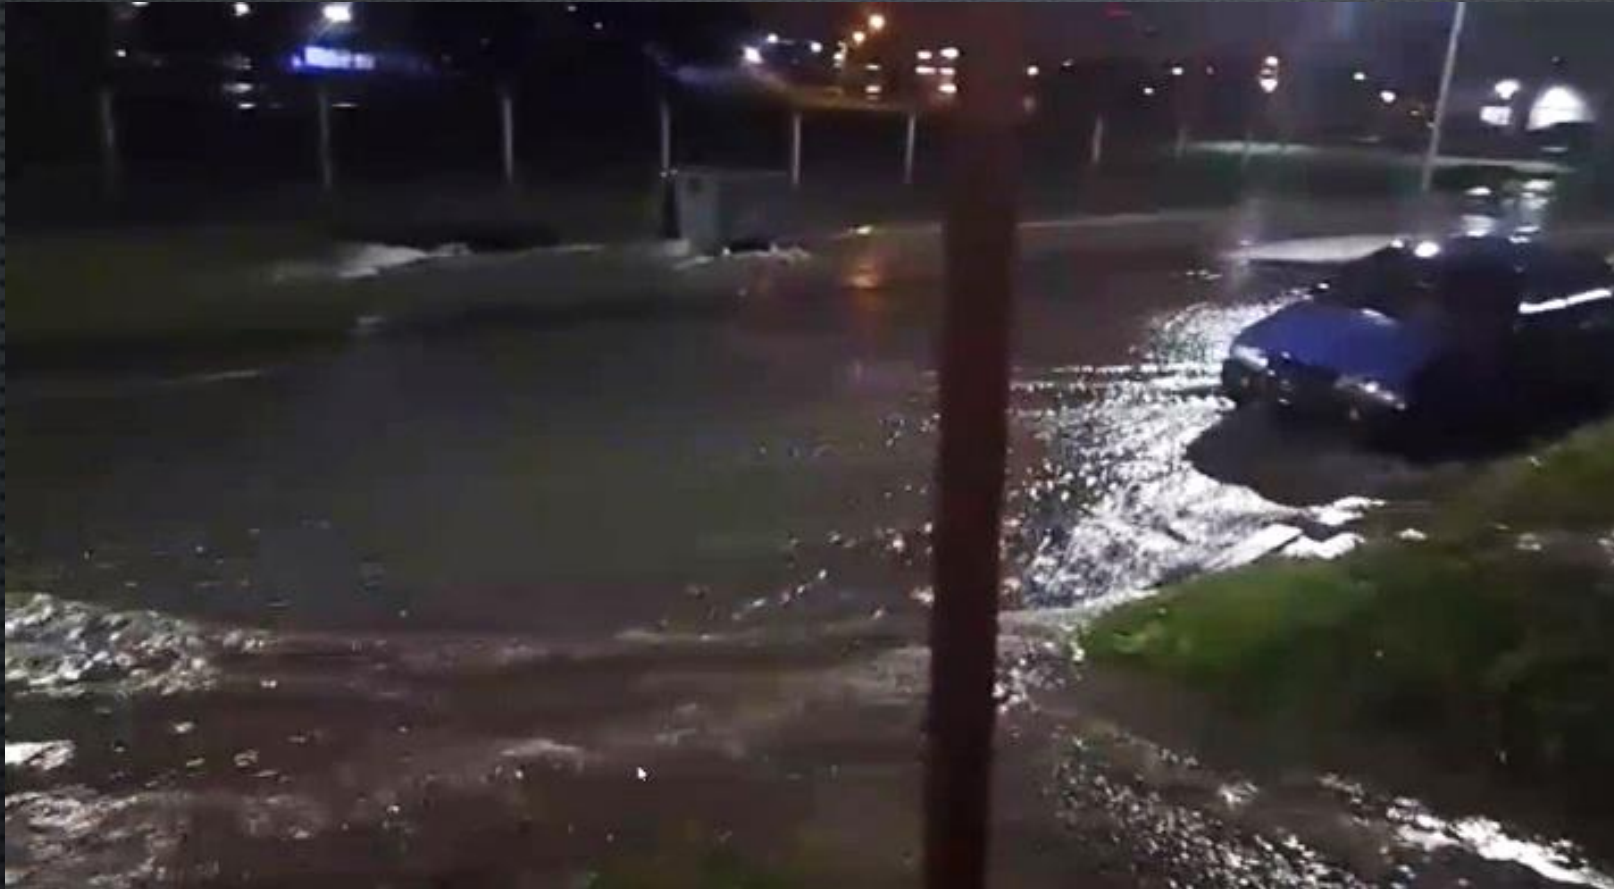
Rondeau Avenue's Flooding

- The street is overflowed from side to side and also advances onto the edges of the sidewalk.

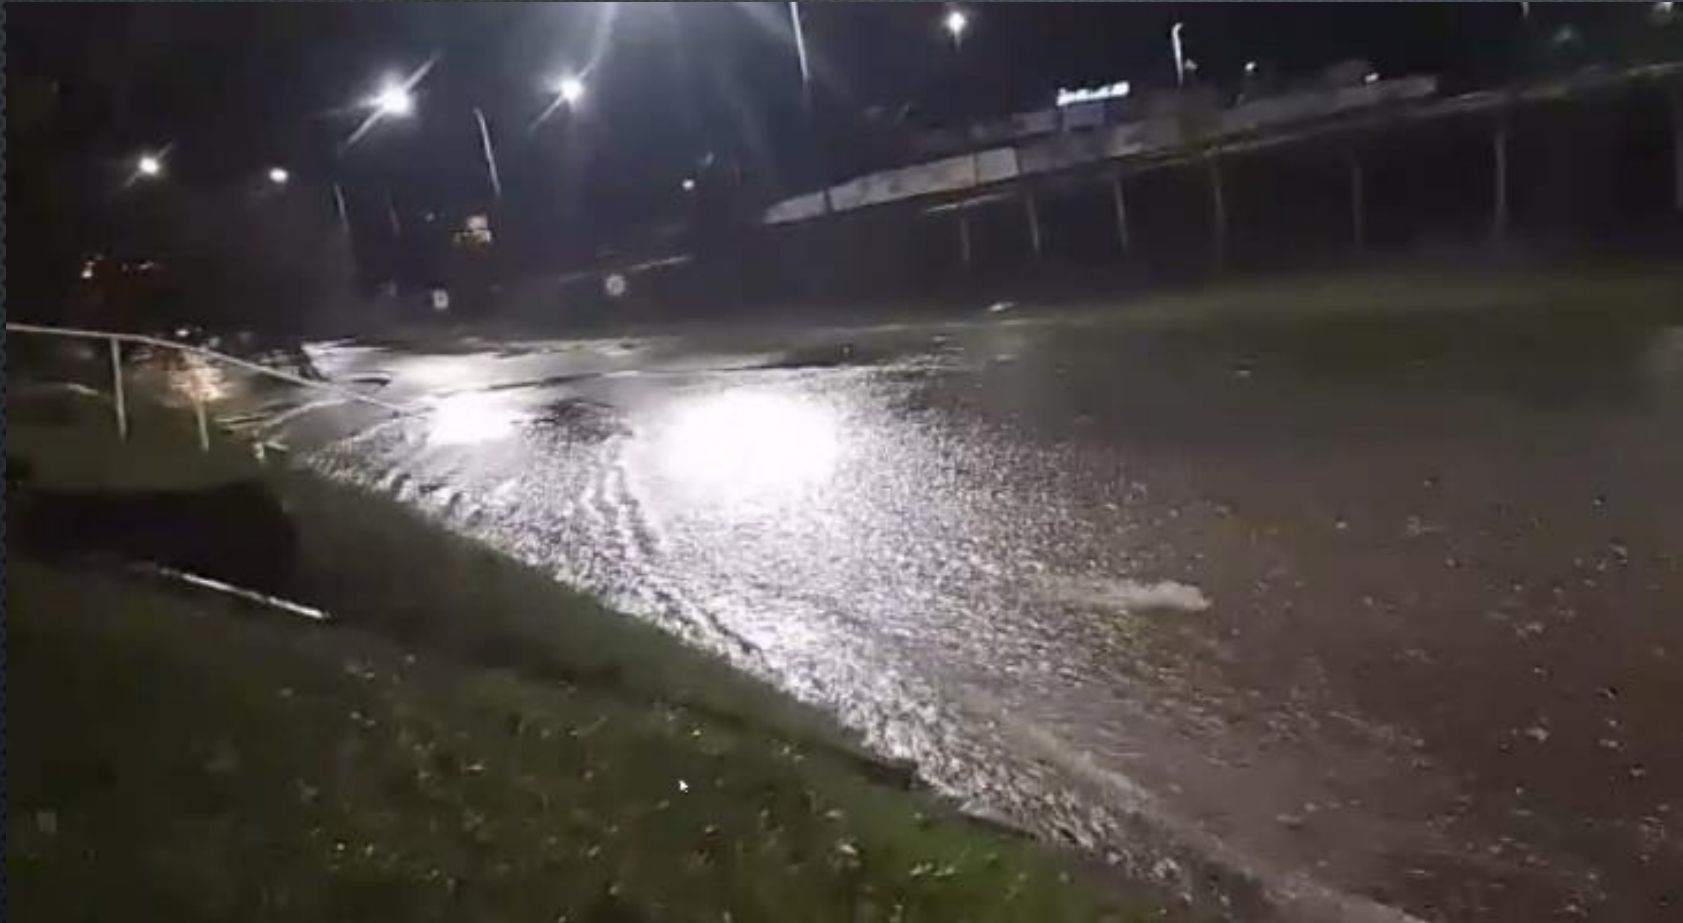
Rondeau Avenue's Flooding

- The water flowing from east to west, following the direction of the North access route
- Drains cannot cope with the volume of this flow.

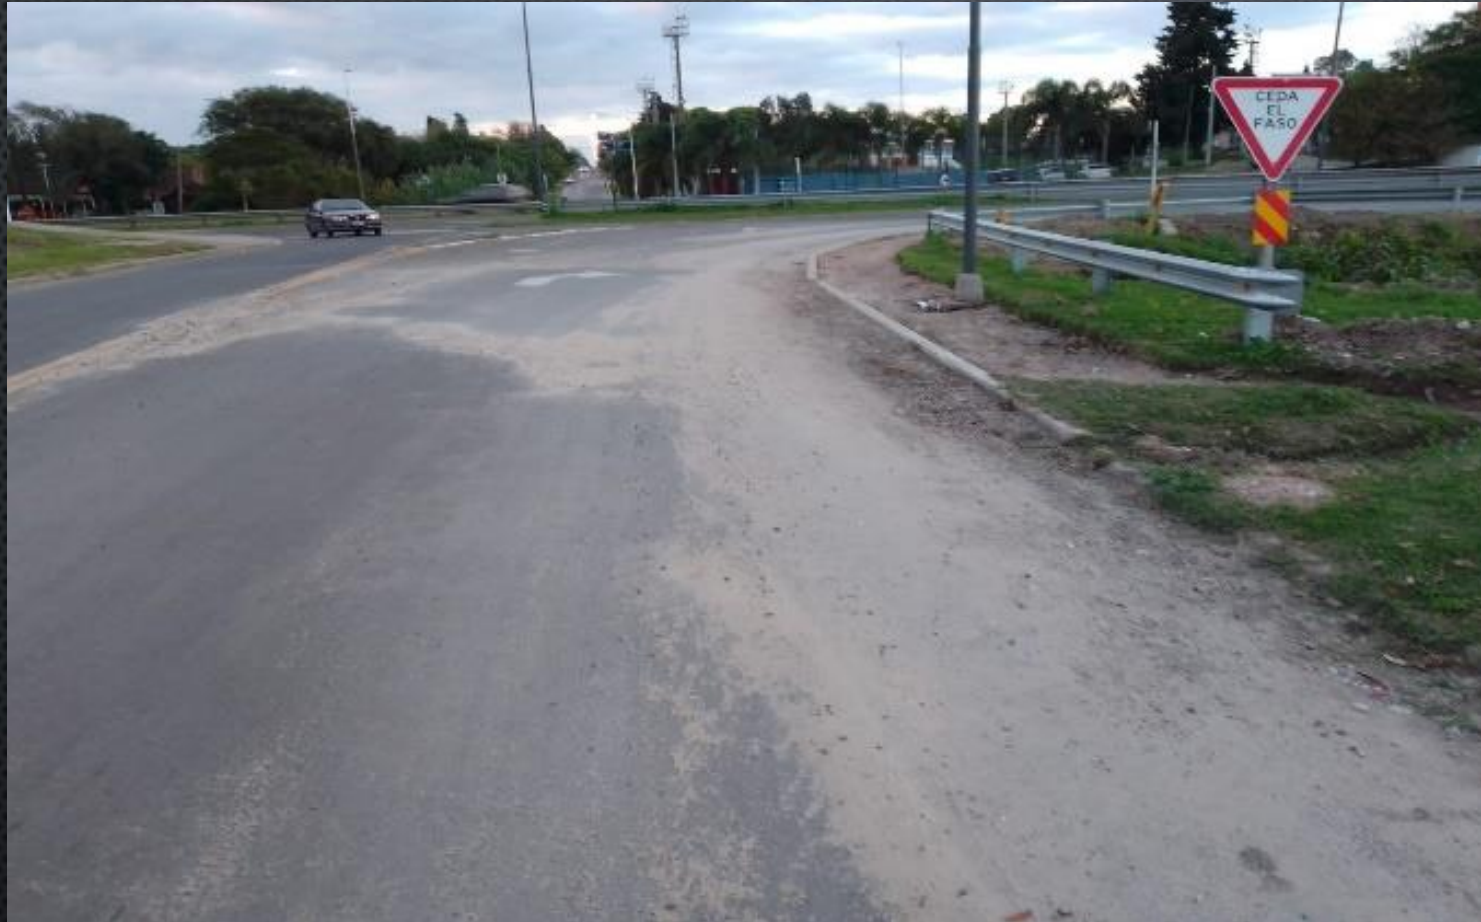
Rondeau Avenue's Sedimentation

- A lot of sediments are accumulated on the asphalt after rainfall.

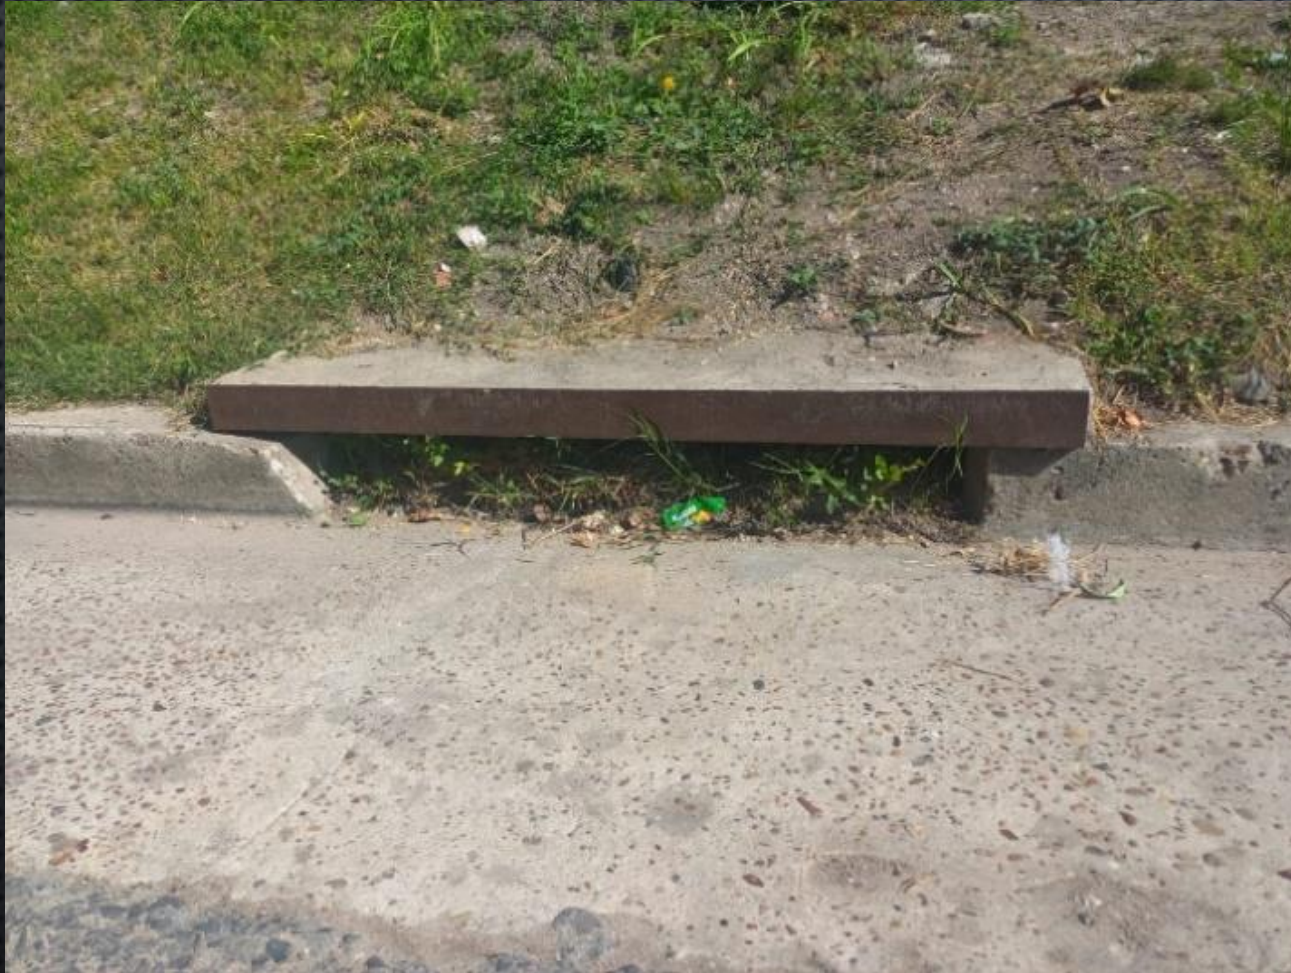
Obstruction of Storm Drains

- Inadequate maintenance of the stormwater drainage system
- Progressive sediment accumulation due to rain
- Three out of ten storm drains need for comprehensive unclogging

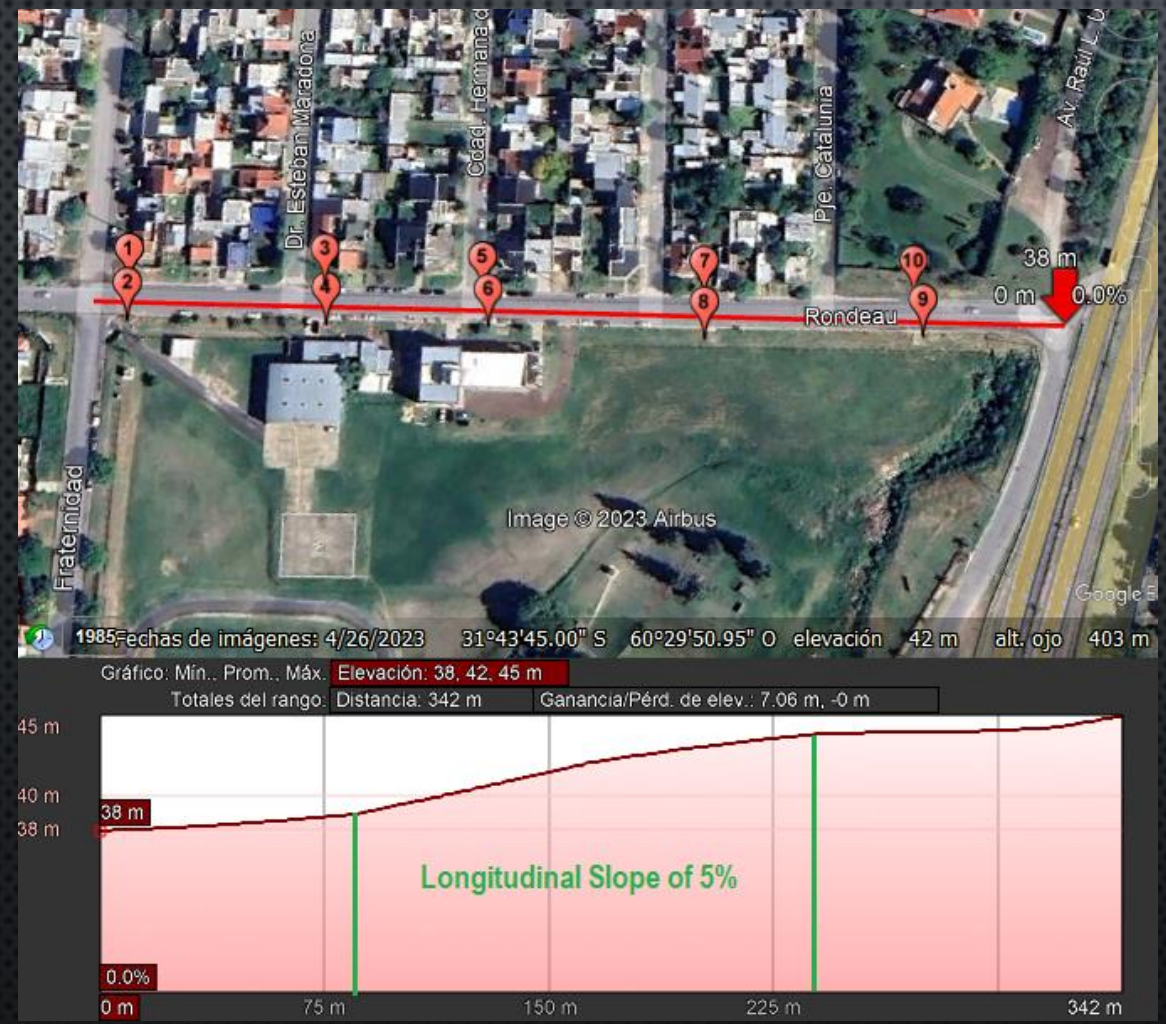
Excessive Longitudinal Slope

- The presence of curb opening inlet type storm drains
- Efficiency of this type of sink for longitudinal slopes less than 3%
- Existence of an area with a longitudinal slope exceeding this percentage

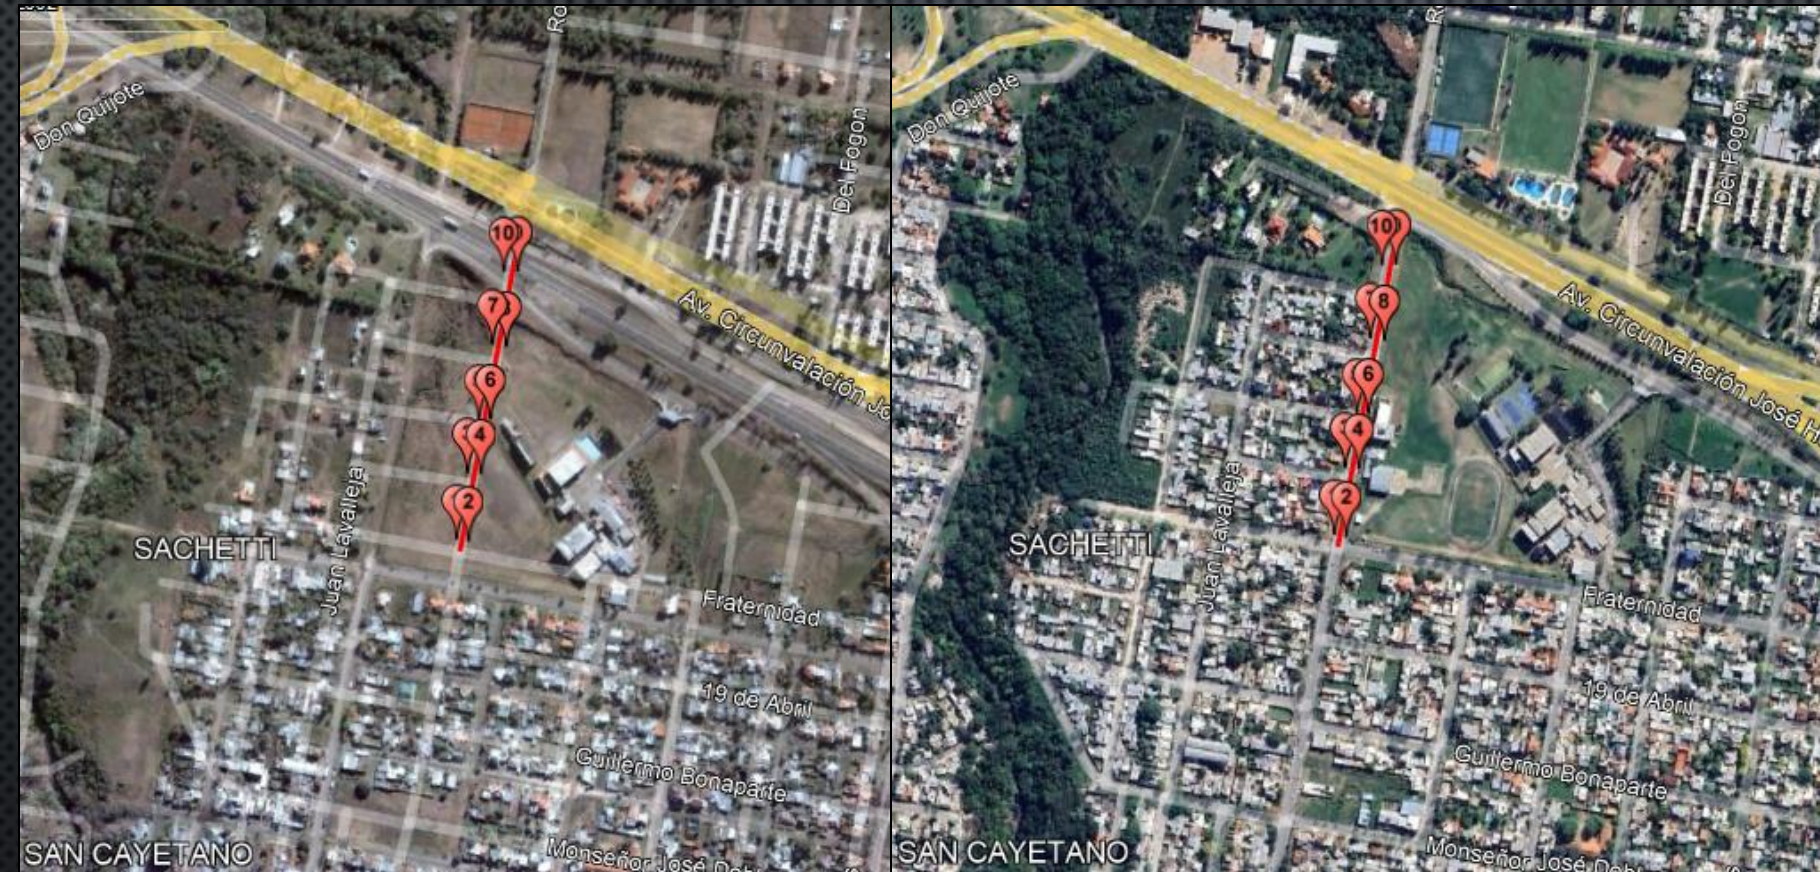
Reduction of Absorbent Surface

- Decreased water runoff due to limited absorbent surface caused by urban expansion
- Recent significant urban growth in the region

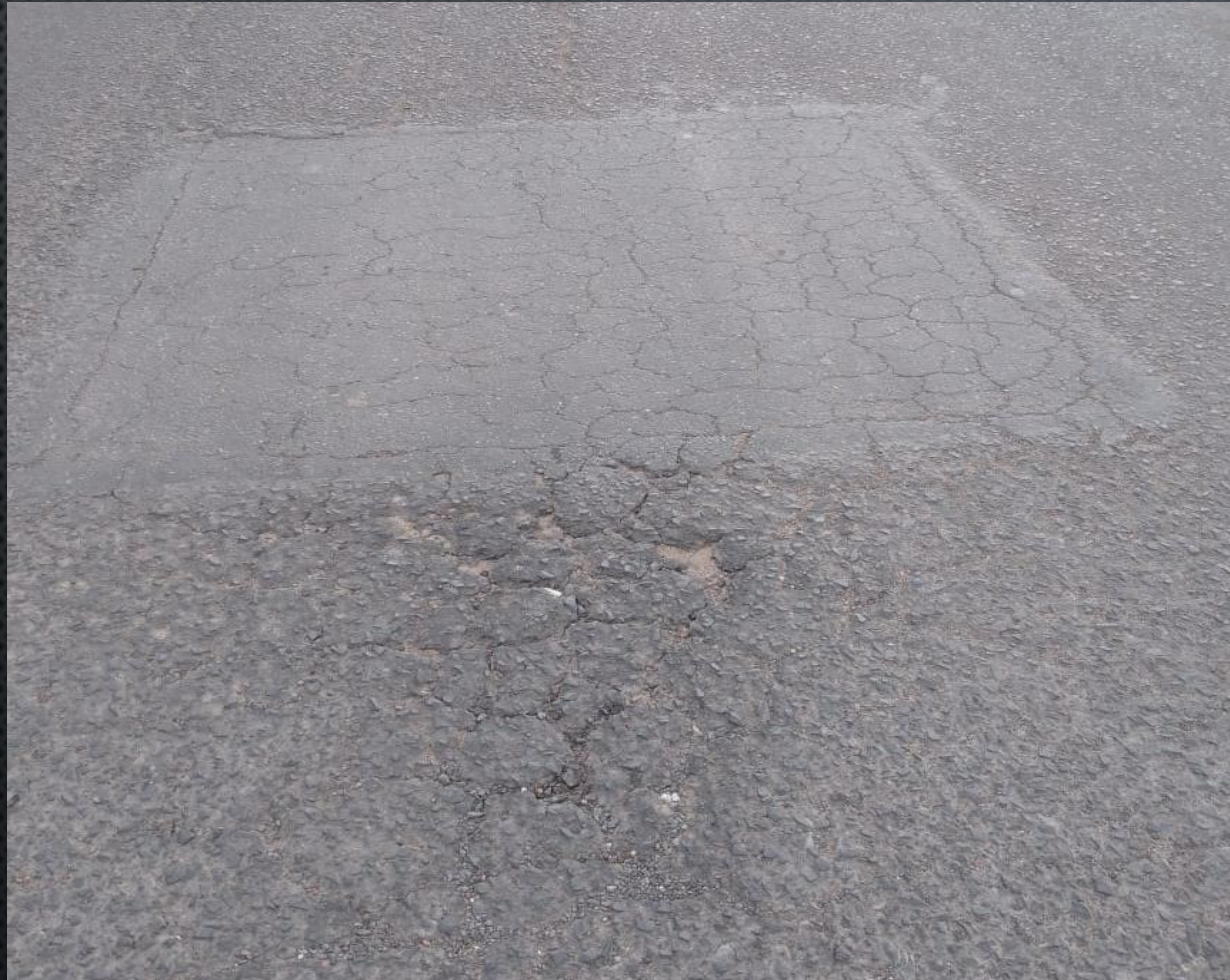
Pavement Breakage and Safety Risks

- Risk to vehicular and pedestrian safety due to poor pavement grip and visibility
- Gradual pavement cracks and their increase due to traffic from floods
- Skidding risk for vehicles at the junction curve between Rondeau Avenue and Uranga Avenue

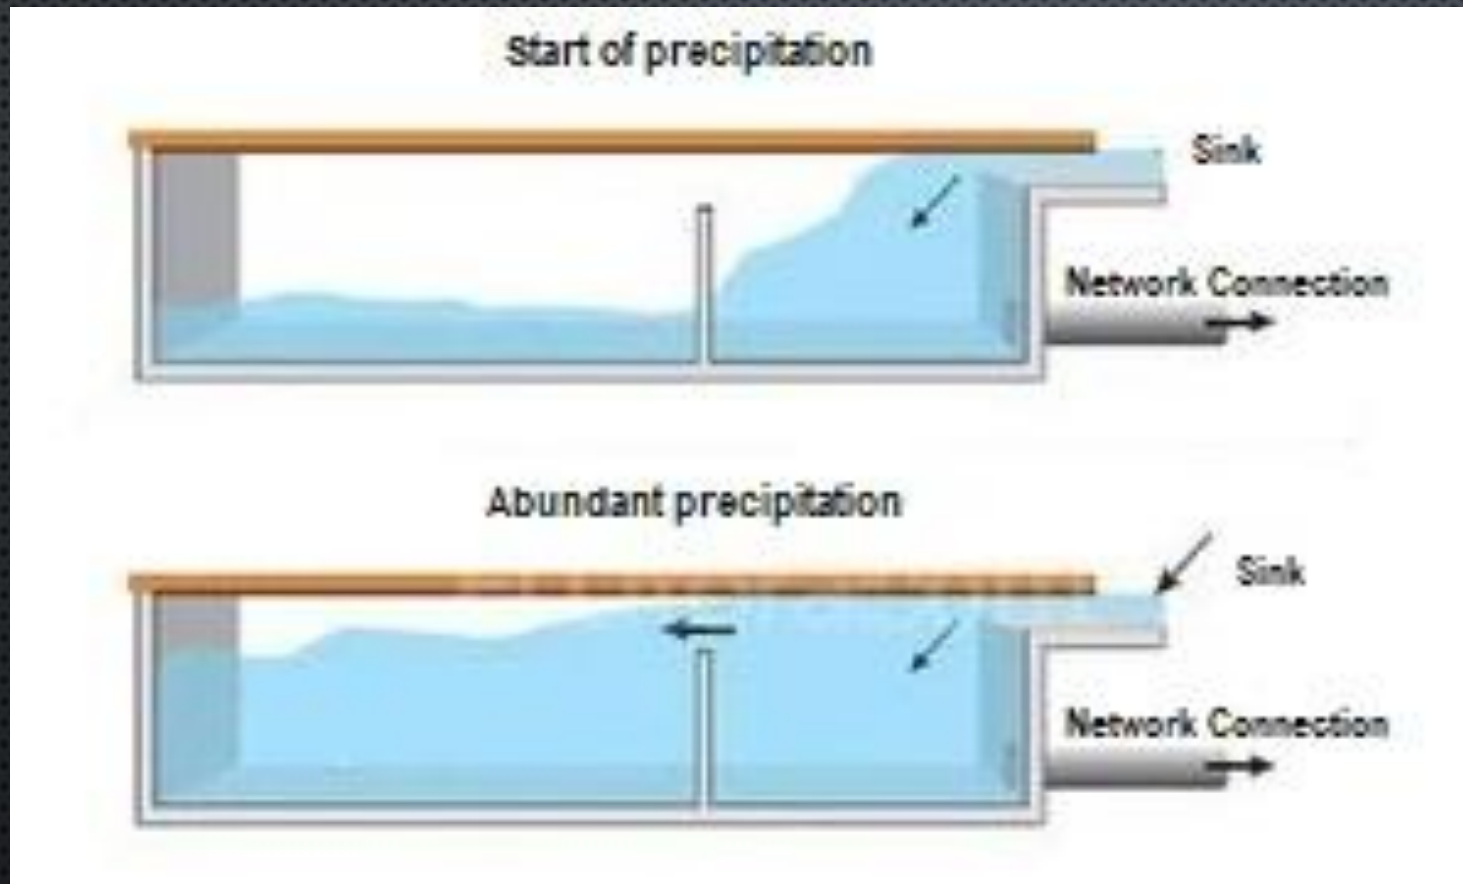
Reservoir Functioning

- Pluvial retarders are needed.
- These are connected directly to the storm drains and to the drain network's pipelines.
- They are divided into two compartments.
