Inefficient Interurban Connection: Modernisation of the Paso Bravo Bridge

Summary: The Paso Bravo bridge located in Feliciano Atencio, Entre Ríos, suffers from poor maintenance and obsolete infrastructure, causing safety risks and traffic congestion. This project proposes modernizing the bridge using recycled materials like high-density polyethylene and polystyrene, inspired by the Easter Dawyck Bridge in Scotland. Despite initial costs, the solution offers long-term benefits such as reduced maintenance, lower emissions, and improved traffic flow, enhancing safety and fostering economic development in the region. The expected impact of this project is mainly to analyse a way to improve the quality of life and safety of people while preserving the environment.

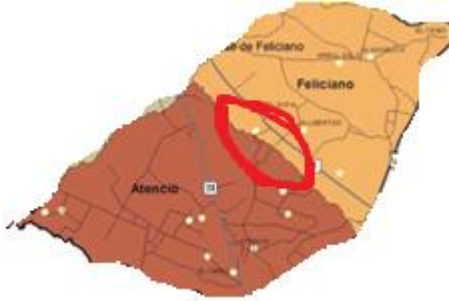
Fig. 2 shows a red line marking the area where the problem is located. The San José de Feliciano district is the most important part of the city as it is the most populated place and where people buy their goods and other supplies. On the other hand, the Atencio district, which is shown in a darker color in Fig. 2 is another important district in Feliciano due to its contribution to cattle raising.

Fig. 2. Location of the bridge

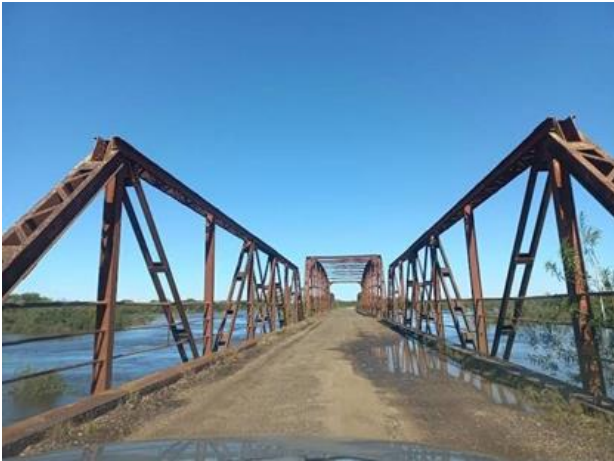
Fig. 3. Bridge that joins Atencio and San José de Feliciano.

Fig. 3 shows the bridge in need of modernization to put an end to the problems suffered by people due to the difficulties it presents. The structure is 6 meters high and 100 meters long.

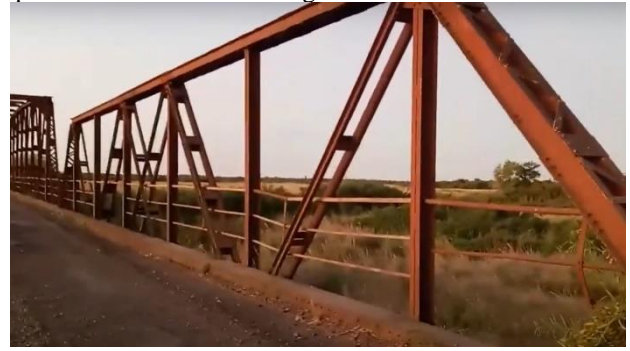
Fig. 4 shows the old bridge located in *Paso Bravo*, Feliciano. To the right of the picture, the rusted metal structure of the bridge stands out, with its beams and crossbeams showing signs of wear and tear and deterioration due to the passage of time. In the background, the landscape is predominantly rural, with fields and low vegetation

stretching towards the horizon. Lack of maintenance is evident in the rusted parts, highlighting the need for urgent repairs to ensure safe crossing.

Fig. 4. Bridge in Paso Bravo Feliciano with visible rust and wear.

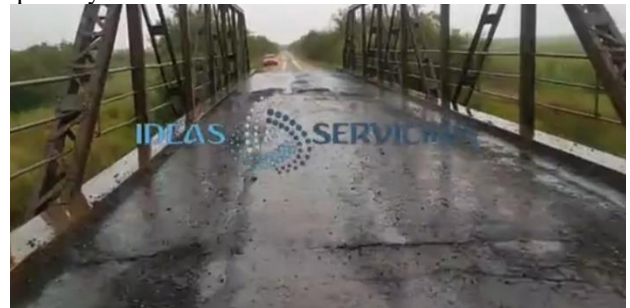
Fig. 5 presents a surface view of the bridge at Paso Bravo, Feliciano. In the centre of the picture, the pavement is visibly damaged, with numerous potholes and water accumulation due to recent rains. The side railings of the bridge, as in the first picture, show signs of corrosion. In the background, the road is visible extending in a straight line, indicating that this bridge is an important road for vehicular traffic. The condition of the pavement and the metal structure suggest a considerable danger to vehicles travelling across this bridge, especially in adverse weather conditions.

Fig. 5. Damaged surface of the bridge in Paso Bravo, Feliciano.

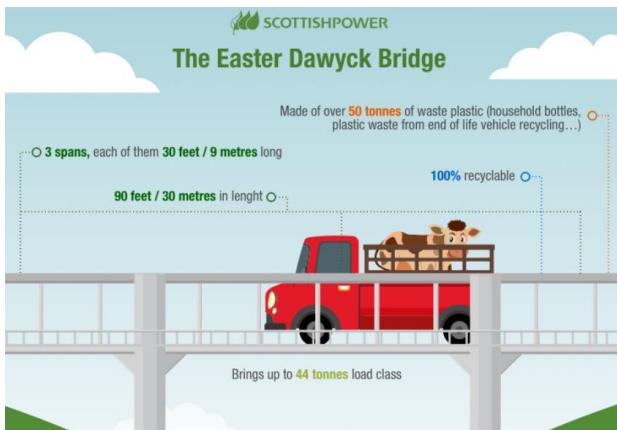
Its construction implements the use of recycled high-density polyethylene, which is combined with polystyrene. This is a more durable material than wood and requires no maintenance. Most importantly, it is fully recycled and recyclable. Fig. 6 shows the idea of the bridge.

Fig. 6. Easter Dawyck Bridge, in Scotland

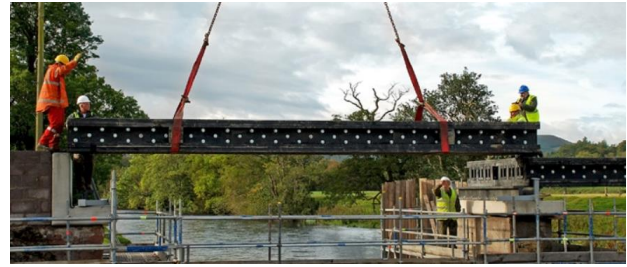
The construction method is quite simple because its material consists of prefabricated planks, which are supported on the bridge piers, which have a maximum spacing of 9 metres. The planks are then simply assembled. Fig. 7 shows the construction of the bridge in Scotland.

Fig. 7. Method of construction

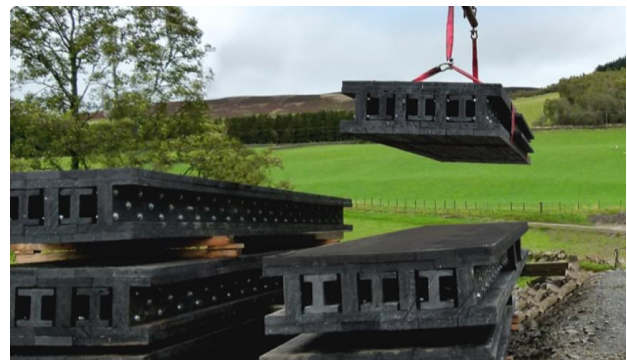
As well as this, its construction method is simple. This lowers construction costs because the materials are prefabricated to size, as Fig. 8 shows.

Fig. 8. Planks used in this construction.
