# Damaged RC beams strengthened with near surface mounted technique using fiber reinforced polymers

Strengthening reinforced concrete (RC) structures with fiber-reinforced polymer (FRP) composites is becoming an attractive alternative for repairing of damaged structures. In the case of reinforced concrete beams, reinforcement with FRP enhances the flexural capacity and shear strength. FRP strengthening can be applied as externally bonded FRP laminates or near surface mounted (NSM) FRP rods.

The flexural behavior of damaged reinforced concrete beams repaired with NSM technique using glass fiber reinforced polymer (GFRP) bars is experimental studied in this work. Two set of beams were tested: control beams (without GFRP bars) and damaged and then repaired beams with GFRP bars by varying two parameters (damage degree and concrete strength class).

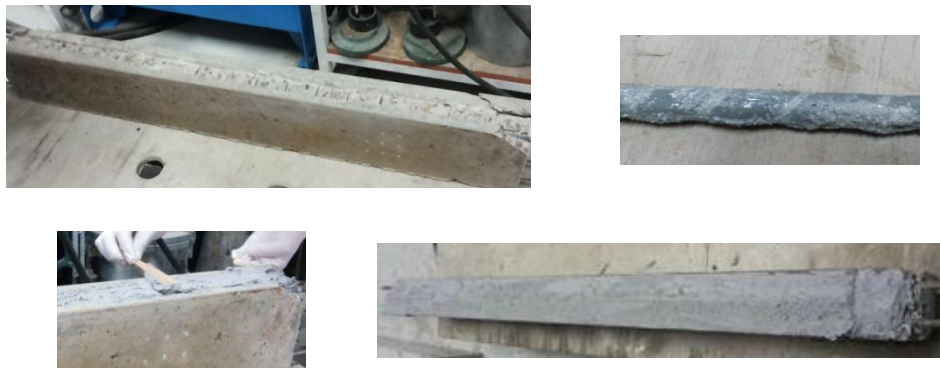
Figure 4. Steps of the reparation process.

The GFRP rod was installed in the damaged beams by making a cut in the concrete cover in the longitudinal direction at the tension side. A special concrete saw with a diamond blade was used. Groove size of  $20 \times 20 \text{ mm}^2$  was cut for a GFRP bar of 12 mm diameter and then it was half-filled with epoxy resin. The GFRP bar was then lightly pressed into the resin. Finally, more resin was added and the surface leveled (Al-Mahmoud et al., 2009, Soliman et al., 2010, Choi et al., 2011, Standard ACI 440 1R-06). Figure 3 shows the steps of the reparation process.

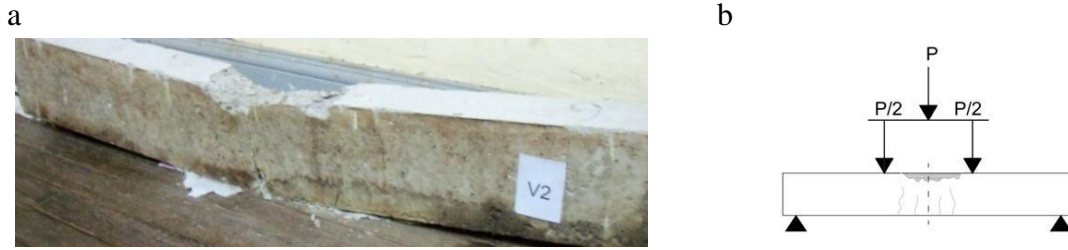
**Figure 6. (a) Failure of the control beam and (b) schematic drawing.**

The failure mode of the control beams was by steel yielding giving a large deflection of the beam. This failure mode is characterized by the appearance of two first cracks localized under the two loads (Figure 6), followed by the appearance of micro-cracks between the two large cracks. Finally and by increasing the load, concrete crushing happened.

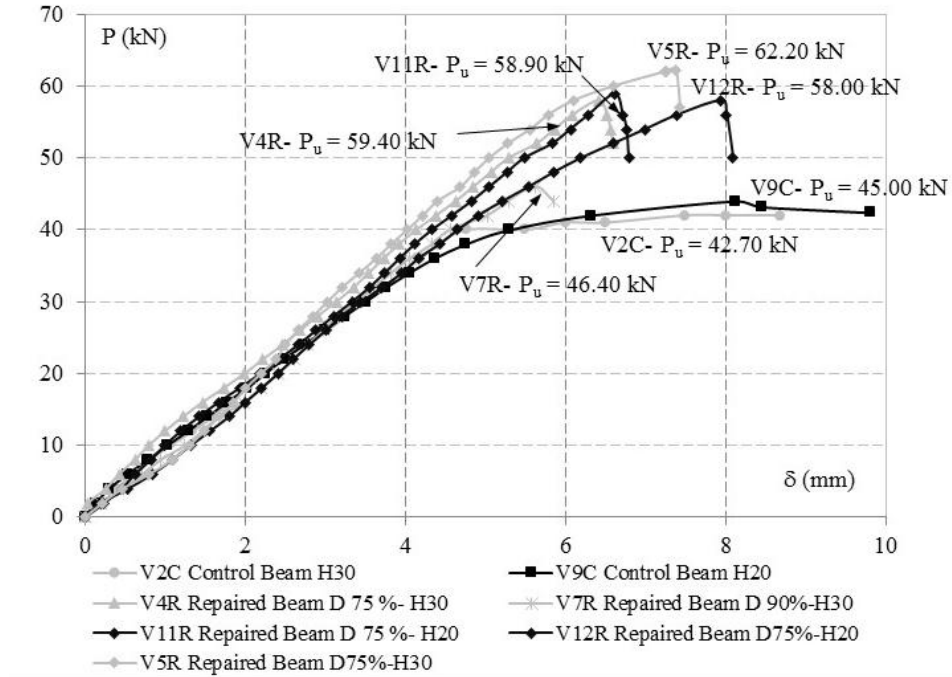
**Figure 8. Load- deflection curves for beams strengthened with NSM GFRP bars.**

The load–mid span deflection responses for some individual beams, with different damage degree and different concrete strength class, are plotted in this Figure 8. Control beams had a significant ductility. On the other hand, the behavior of all repaired beams was brittle due to the

purely elastic behavior or GFRP bars. A slight increase in stiffness, in beam V4R (D= 75% and H20), was reached. All repaired beams recovered and improved the bearing capacity in comparison with control beams.

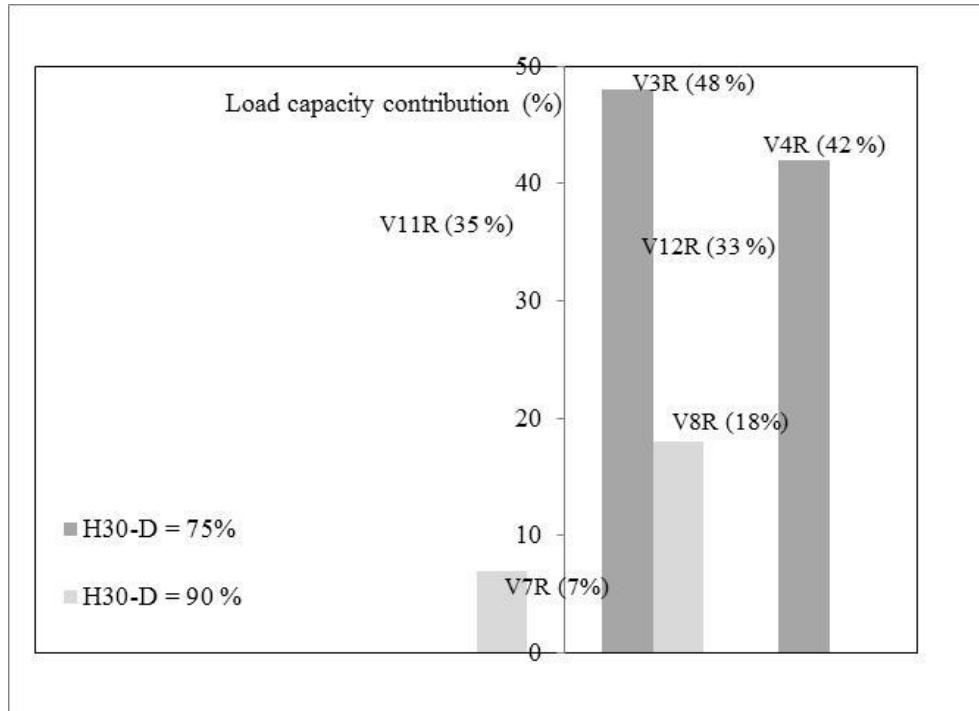
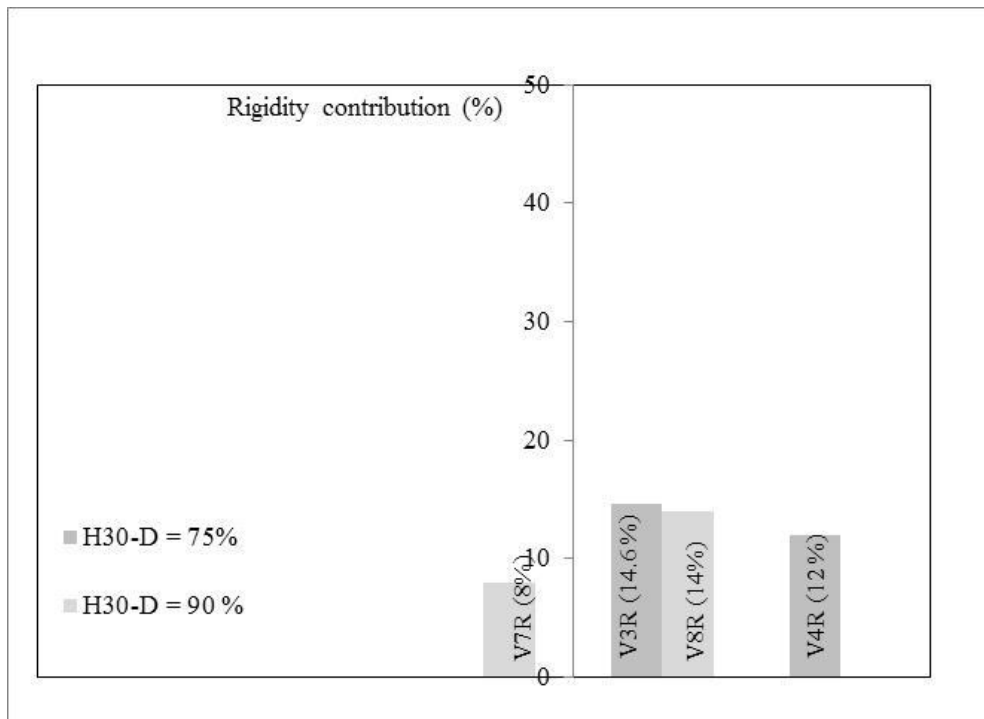
**Figure 10. Load capacity contribution and rigidity contribution taking into account damage degree and concrete strength class**

The load capacity and rigidity contribution of the NSM repaired beams, taking to account damage degree and compared to that of the control beams, are presented in Figure 10. Damage degree was an important influence on bearing capacity of GFRP repaired beams while the influence on rigidity of those specimens was less significative.
