Duplex treatment - plasma nitriding plus TiAlN coating - to protect martensitic stainless steel from severe wear and corrosion

Eugenia L. Dalibón¹, Walter R. Tuckart^{2,3}, Sonia P. Brühl^{1,3}

Universidad Tecnológica Nacional – UTN, Concepción del Uruguay, Argentina

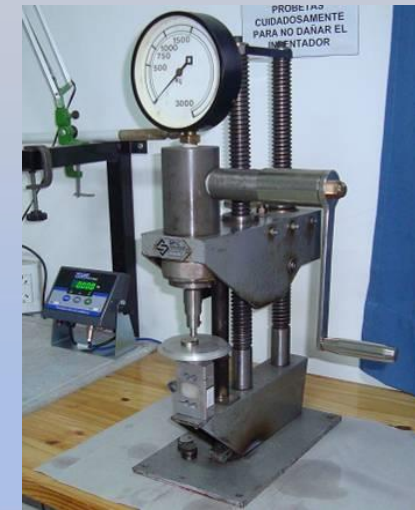
Adhesion
VDI 3198
*Rockwell C
Indentation*

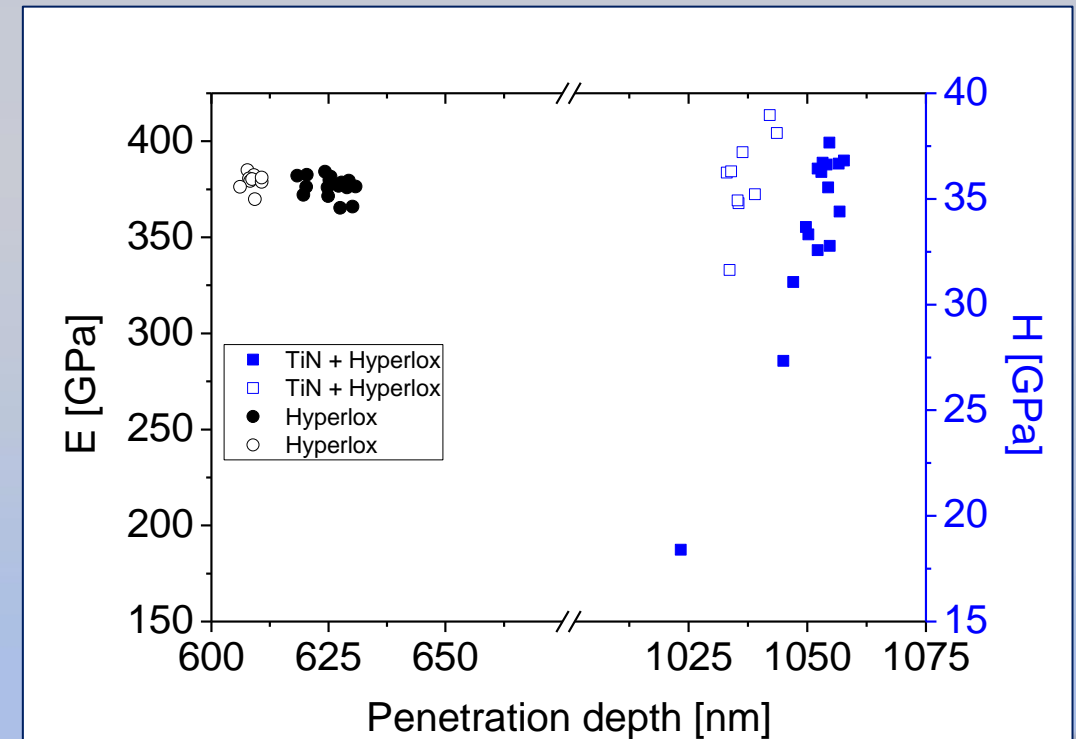
Nanohardness (GPa)	17 ± 1
Young Modulus (GPa)	182 ± 5
Penetration Depth (nm)	124 ± 3

Nanoindentation

Nitrided layer hardness (on top): $(1180 \pm 40) \text{HV}_{0,05}$

AISI 420 stainless Steel (Q&T): $(500 \pm 20) \text{HV}_{0,05}$

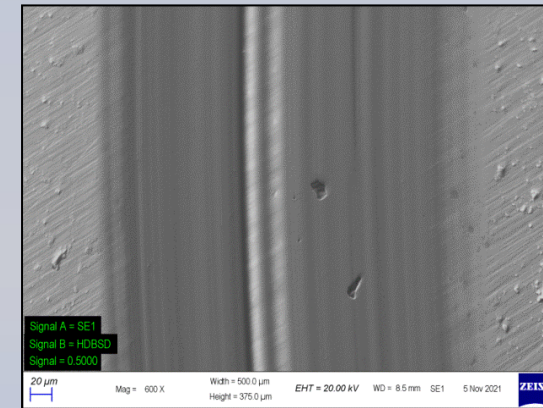
Duplex

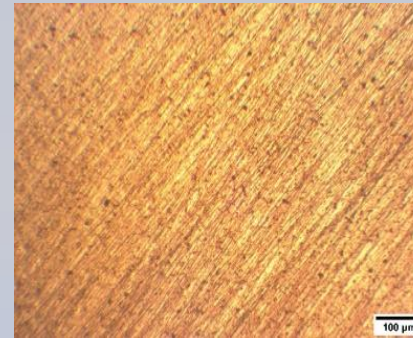
Pits
OM images
In the same
area
