# Tribological Behaviour of TiAlN and AlCrN coatings deposited over martensitic stainless steel

E. L. Dalibon<sup>1\*</sup>, A. J. Maskavizan<sup>1</sup>, S. P. Brühl<sup>1,2</sup>

<sup>1</sup>Surface Engineering Group (GIS), National University of Technology (UTN)  
Faculty of Concepción del Uruguay, Argentina.

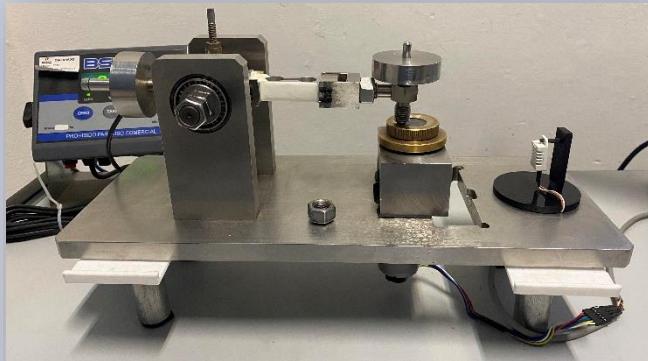
Adhesive  
Pin-on-Disk  
ASTM G99

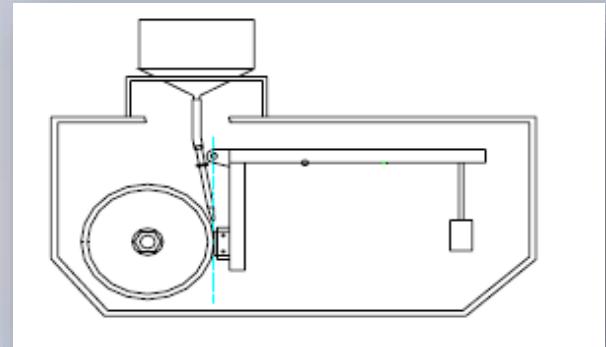
Abrasive Wear test  
ASTM G65-94  
“Dry Sand- Rubber  
Wheel”

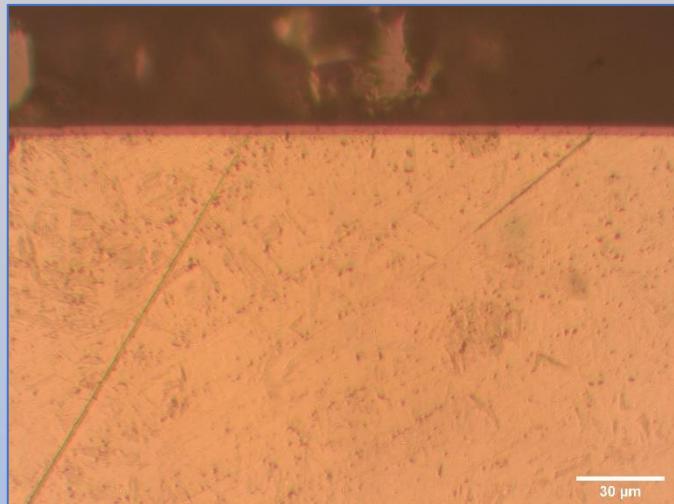
AlCrN coating

OM images on different samples

### Thickness

CrAlN coating ( $3.1 \pm 0.2$ )  $\mu\text{m}$

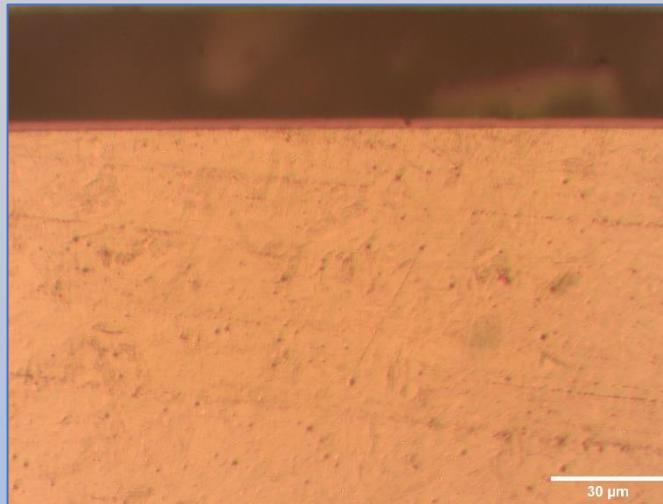
TiAlN coating ( $3.3 \pm 0.3$ )  $\mu\text{m}$

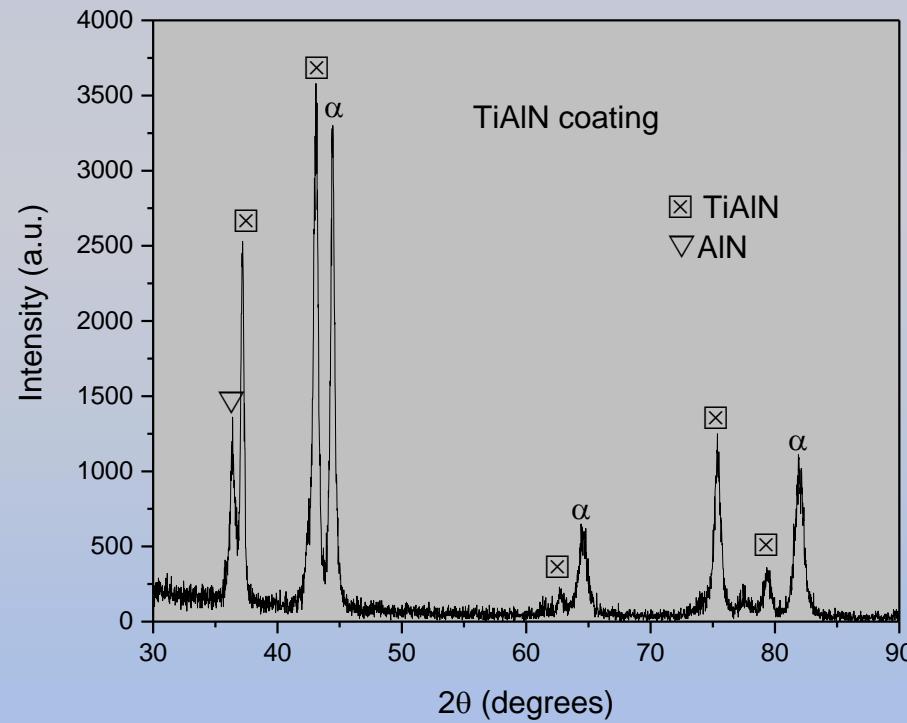
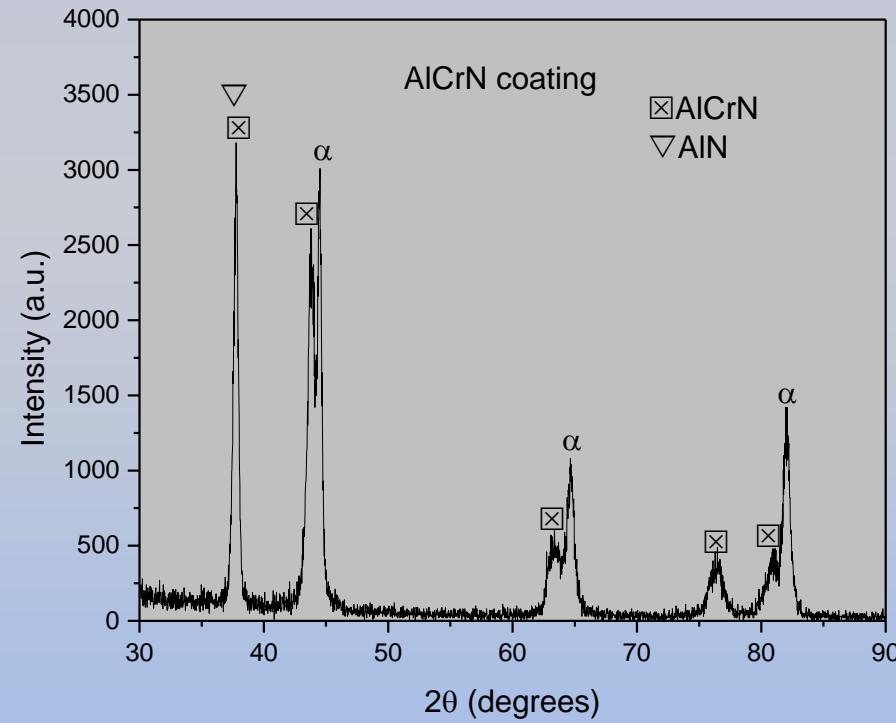
Diffractograms  
of the coatings

## Microstructure

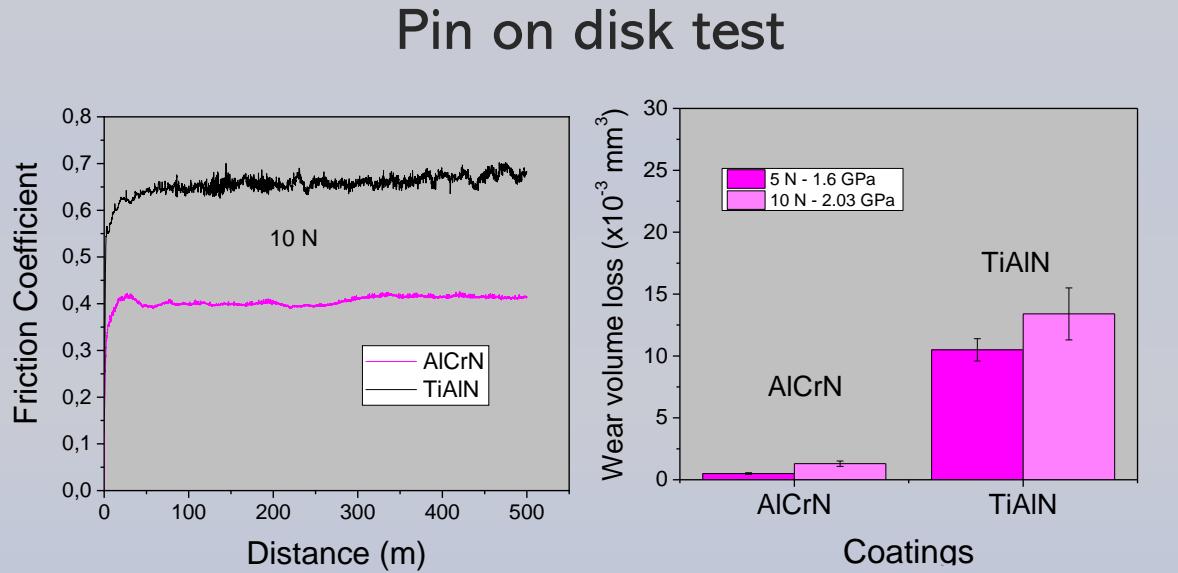
Friction coefficient  
Wear volume loss

1. The thickness reached approximately 3  $\mu\text{m}$  in both coatings.
2. The mass loss was similar for both coatings under abrasive wear ASTM G65.
3. The AlCrN coating has better performance under sliding conditions. The wear volume loss was twenty-five times lower for the AlCrN than the TiAlN in pin on disk tests, under low and high loads, and the steady friction coefficient value was also lower.
4. In the scratch tests, the AlCrN coating failed under a higher load than the TiAlN, which would indicate a higher critical load.
5. Nevertheless, the deformation was greater for AlCrN than TiAlN coatings.

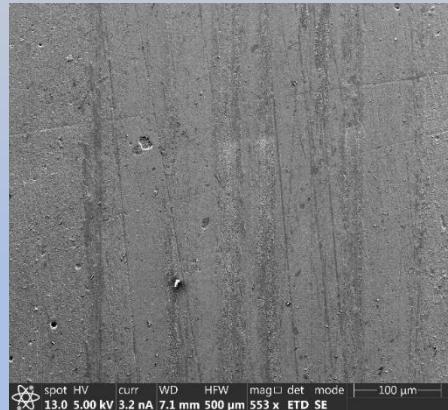
AlCrN coating

Wear tracks

SEM images

Maximum depth of wear track  
TiAlN coating:  $(2.1 \pm 0.4) \mu\text{m}$   
CrAlN coating:  $(0.30 \pm 0.03) \mu\text{m}$

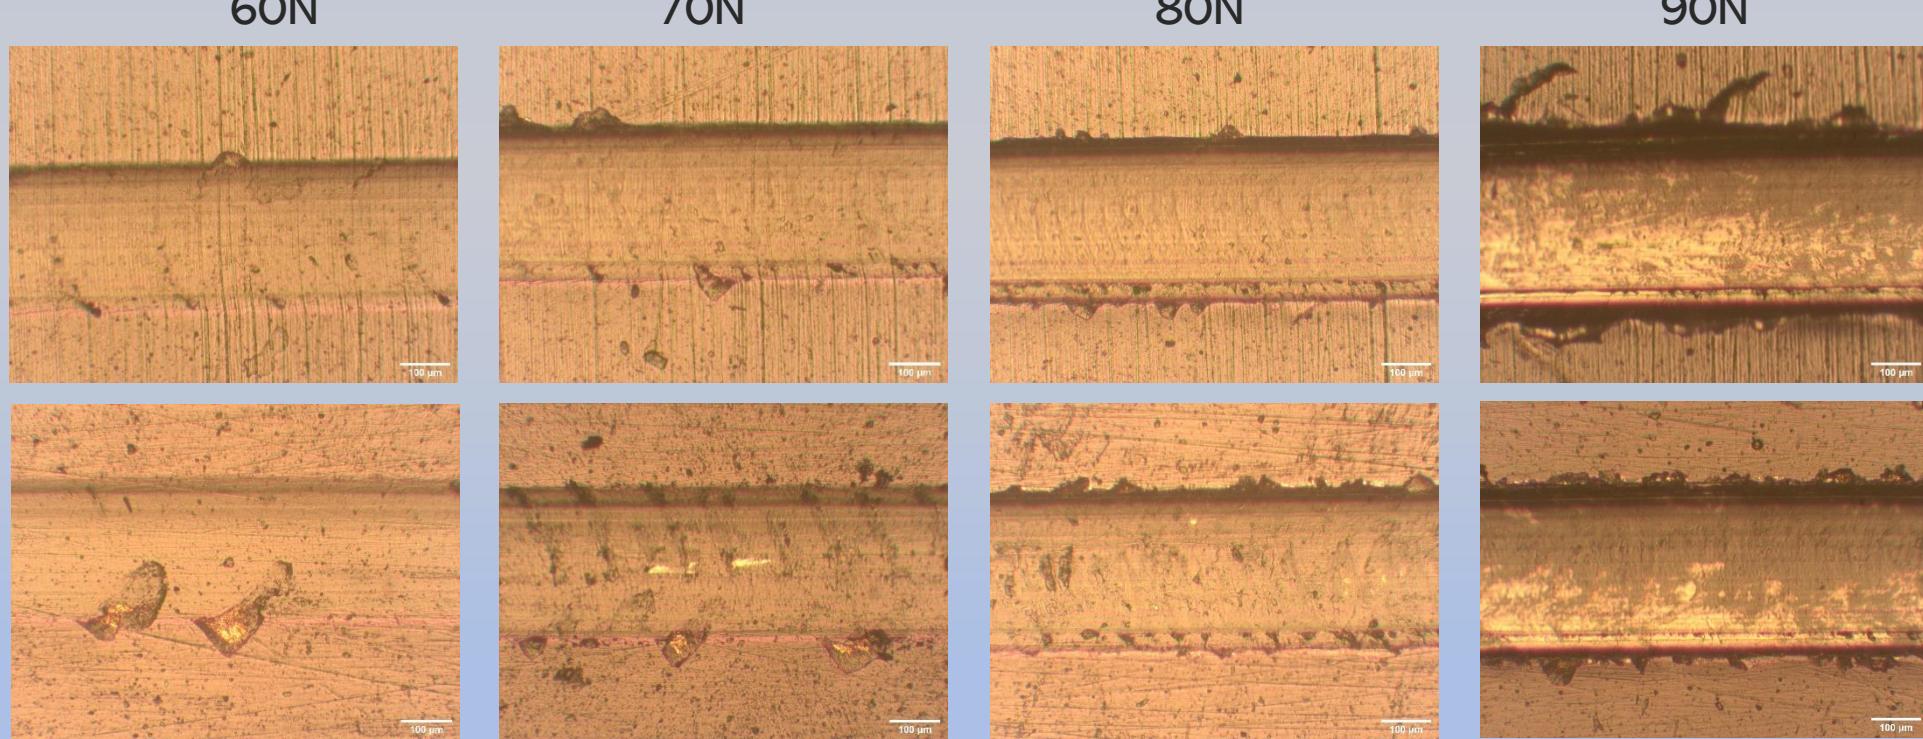
## Scratch tests tracks

AlCrN coating

TiAlN coating

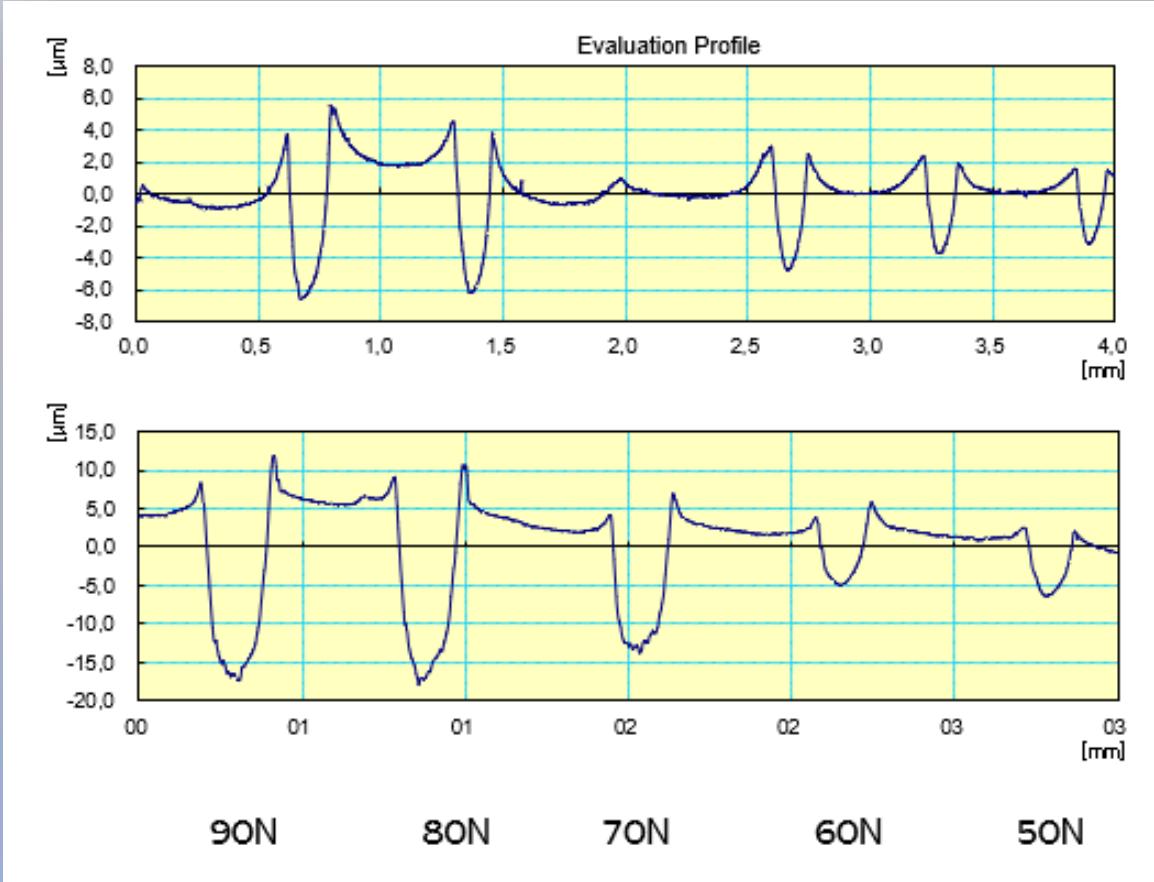
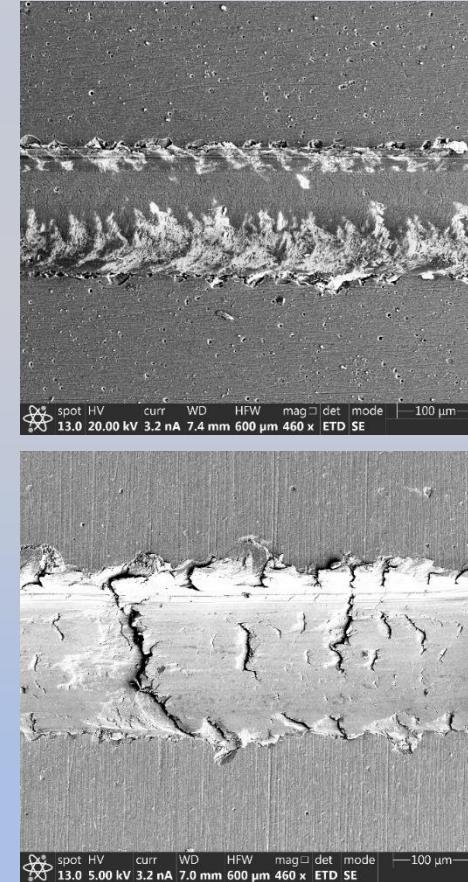
## Scratch tests tracks profiles

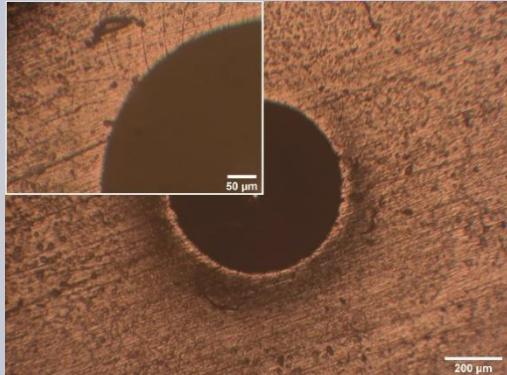
AlCrN coating

## Indentation Rockwell C

OM images

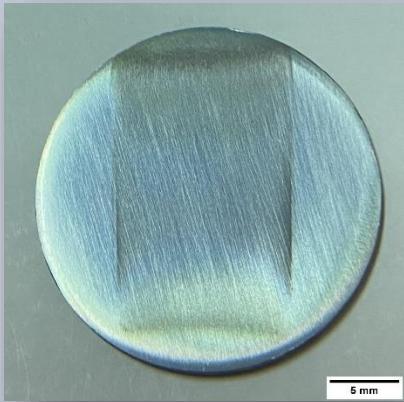
AlCrN coating

## Abrasive wear

*While in the heat treated stainless steel, the mass loss was about 250 mg (130 N, 30 min), in the coated samples, it was undetectable.*
