# Landslides in Urquiza Park: The Use of PET Fibers to Avoid the Movement of Hillsides

**Summary**—Urquiza Park is an important green area of the city of Paraná. Currently, it is facing a critical issue related to landslides and erosion. The causes are mainly heavy rains and trees removal, destroying the environment and putting people at risk. The purpose of this project is to address the issue of landslides within the specific area of Urquiza Park. To fulfill this aim, a solution that can be implemented by future civil engineers will be explored and explained, involving the reuse of recycled PET fibers to prevent landslides and erosion of this area. In order to achieve the goal of this work, it is organized as follows. Firstly, the city of Paraná will be briefly described. Then, the Urquiza Park landslides problem will be presented and discussed. Next, some scenes will be described in order to help visualize the problematic situation. Later, the causes as well as the consequences of the problem will be identified and analysed. After this, the solution to address the problem will be discussed. Finally, the strengths and weaknesses of the proposal will be stated. The expected impac

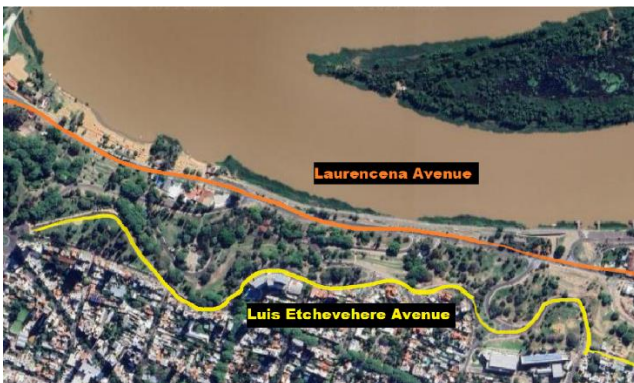
Fig. 8. Hills between the avenues.

This is the specific area where the problem is located. There are numerous hills that are prone to landslides and erosion between Laurencena Avenue and Luis Etchevehere Avenue, as Fig. 8 shows. These hills have an average height of 50 meters and there are many trees and stone stairs on them. Also, a lot of different kind of birds and small animals live in this area, so it is important to preserve the vegetation. The next pictures depict these areas.

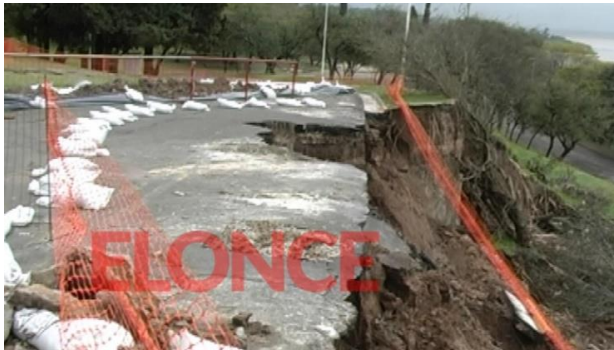
Fig. 12. Landslide caused by terrain movement.

As shown in Fig. 12, we can observe Luis Etcheverehere Avenue surrounded by trees. The collapse of the road is evident, with large sections of broken pavement. The scene depicts the consequences of a landslide that has disrupted the calm of the landscape. The once-smooth surface of the road is now completely unusable and there is a big impact on the environment produced by rubble.

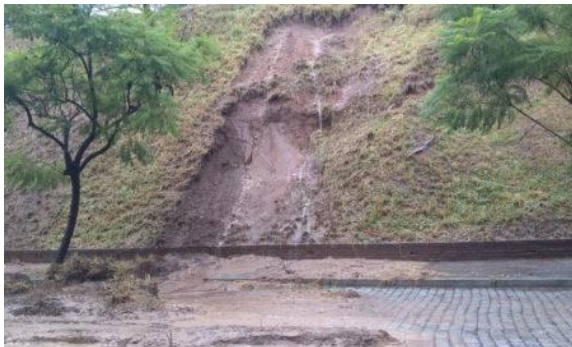
Fig. 13. Landslide due to diluvium.

The scenario in Figure 13 is similar to Figure 12. The landslide has caused a large amount of soil and rocks to fall onto the walk path below, which is on Laurencena Avenue. The path, which is made of brick, is covered in mud and debris from the hillside. The tree on the left side of the image is bent and damaged due to the landslide. Fortunately, there were not any people harmed during the incident.

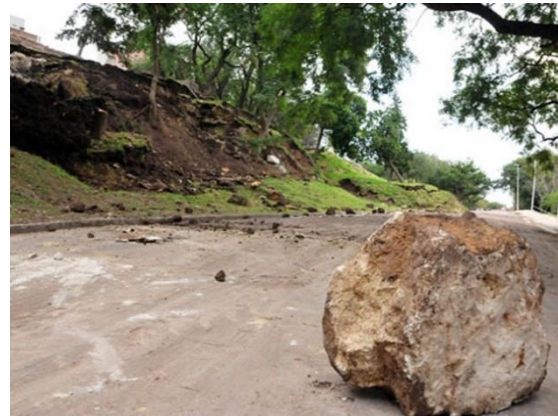
Fig. 14. Rock obstructing Luis Etcheverehere Avenue.

The picture above (Fig. 14) depicts a dangerous situation. There is a large rock in the middle of Luis Etcheverehere Avenue because of a landslide. The hillside behind the road has some sloped trees on it.

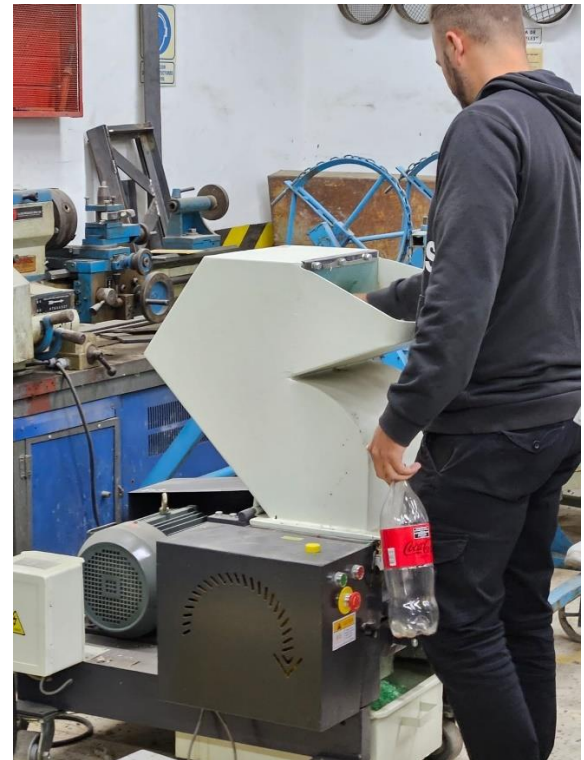
Fig. 17. Extruder from UTN laboratory.

It is known that the amount of plastic discarded daily in Paraná is huge. In this sense, an important part of clean plastic is collected from supermarkets (Fig. 16), such as packaging and empty bottles. Continuing with the process, they are taken into an extruder, as shown in Fig. 17, which chops the bottles into small pieces. The result is plastic flakes, or PET fibers, ready to the next step. These PET fibers are visible in Fig. 18.

Among the main disadvantages of this proposal, it should be noted that, despite having an extruder machine at a UTN laboratory for studying PET fibers, the city of Paraná lacks a recycling facility with the necessary infrastructure for large-scale production of this material. Concerning its usage, it comes with a higher initial installation cost and regular maintenance expenses due to the risk of clogging, as maintenance is required approximately once every two years. Furthermore, it is essential to consider the importance of precise installation and its limited suitability for all geotechnical applications, as they may not be the ideal solution in some cases.

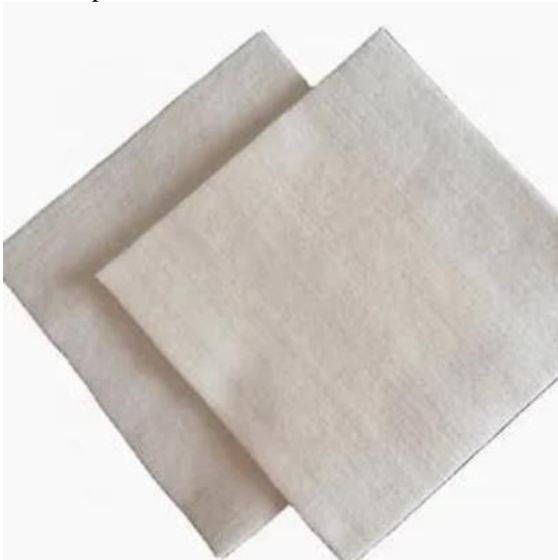
Fig. 19. Geotextile made 100% of PET fibers.

The next step involves manufacturing a geotextile. The flakes are carried to the processing plant, located in the Industrial Park in Paraná, where they are melted and molded to create a geotextile. This material is the base for this project because it has important properties that improve the soil, such as high tensile strength and permeability control. Allowing water to drain through it is necessary to prevent soil saturation, which leads to erosion. This is why it is important to stand out this last property. Fig. 19 shows the final manufactured product.

Regarding the attributes of PET fibers, this material offers high tensile strength, permeability control, dimensional stability under load (i.e. minimal deformation when subjected to loads), resistance to chemicals and degradation, ease of installation, and the ability to reduce long-term maintenance costs in geotechnical projects.

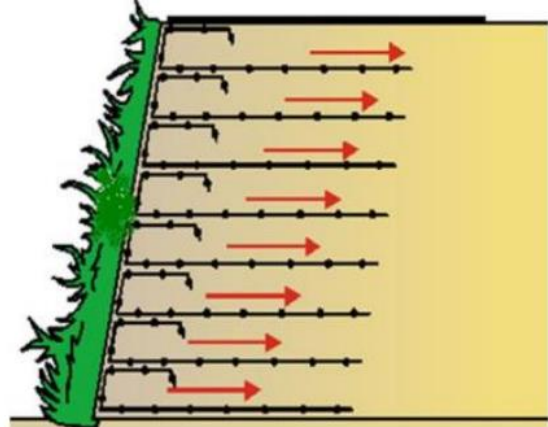
Fig. 20. Schematic way of placement of geotextile.

In this way, the second stage continues. Next, the geotextile is applied to the affected areas of Urquiza Park. In order to achieve this, the first thing to do is to remove the top layer of vegetation. Along with this, about 50 centimeters of dirt are removed. Then, the geotextile is placed in individual layers, from bottom to top as illustrated in Fig. 20. After each

layer is placed, the previously removed dirt is re-deposited and compacted using the appropriate machinery.

Finally, it is necessary to carry out a final compaction, seeking to eliminate any underground air spaces that may have remained. Also, hydroseeding is to ensure that the vegetation's roots stabilize the hillsides of Urquiza Park.
