TECHNICAL PAPER

INCIDENCE OF HEAT TREATMENT ON THE CORROSIVE BEHAVIOR OF AISI 316L AUSTENITIC STAINLESS STEEL

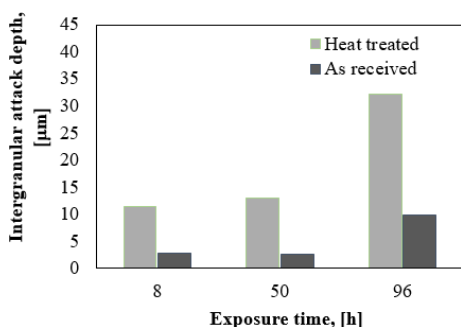
Fig. 7 Intergranular attack depth as a function of spray exposure time.

On the other hand, the heat-treated samples with a high density of carbides exhibited substantial damage from the beginning of exposure to the saline atmosphere. The average depth of intergranular damage increased from 11 µm at the first 8 hours to more than 30 µm at the end of the test, representing an increase of almost 300% in the attack depth, Fig. 7. In contrast, the as-received sample had a lower damage depth of less than 10 µm after 96 hours. All these measurements were determined using Material Plus 4.5 software.
